Access Compliance Report

Public Rights-of-Way

(Curb Ramps)

Intersection ID: 48166	Main Street: NORTHLAKE_MALL_DR	Cross Street: NORTHLAKE_CENTRE_PY	Location: NE
ADA ID: F1828679AC7B	Ramp Type: Perp	Initial Pass/Fail: Fail	Overall Compliance: No
Severity Score: 12.5			
Codes/Mitigation Info/Possible Solution		Field Measurements/Component Compliance

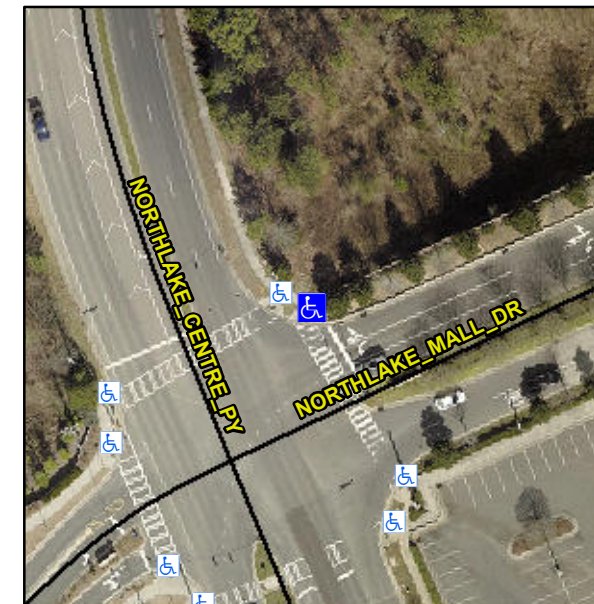
Not Found, R304.5.3

Compliance	Description	Data	Compliance	Description	Data
N/A	Ramp Length (in)	84.0	Yes	Ramp Slope (%)	7.0
Yes	Ramp Width (in)	54.5	No	Ramp XSlope (%)	6.6
N/A	Flare Type LT	N/A	N/A	Flare Type RT	N/A
N/A	Flare Slope LT (%)	N/A	N/A	Flare Slope RT (%)	N/A
N/A	Flare Traversable LT?	N/A	N/A	Flare Traversable RT?	N/A
N/A	Landing Length (in)	N/A	N/A	DWS Provided?	N/A
N/A	Landing Width (in)	N/A	N/A	DWS Contrast?	N/A
N/A	Landing Slope (%)	N/A	N/A	DWS Length (in)	N/A
N/A	Landing X Slope (%)	N/A	N/A	DWS Full Width?	N/A
N/A	Landing Curb? (Y/N)	N/A	N/A	DWS Offset (in)	N/A
N/A	Shared Landing?	N/A			
N/A	Gutter Ponding?	N/A	N/A	Gutter Slope (%)	N/A
N/A	Gutter Lip Ht (in)	N/A	N/A	Gutter X Slope (%)	N/A
N/A	Painted X Walk1?	Yes	N/A	Painted X Walk2?	N/A
	X Walk 1 Direction	To SE		X Walk 2 Direction	N/A
N/A	X Walk 1 Width (in)	104.0	N/A	X Walk 2 Width (in)	N/A
	X Walk 1 Slope (%)	3.8		X Walk 2 Slope (%)	N/A
	X Walk 1 X Slope (%)	2.9		X Walk 2 X Slope (%)	N/A

N/A	Ramp inside XWalk1?	Yes	N/A	Ramp inside XWalk2?	N/A
	Road Slope (%)	N/A	N/A	Clear Space?	N/A
	Road X Slope (%)	N/A	N/A	Clear Space to XWalk (in)	N/A
N/A	Any Obstructions?	N/A	N/A	Storm Grate/Utility Hazard?	N/A
	Obstruction Type			Storm Grate/Utility Type	
		N/A			N/A
			Yes	Surface Condition? (G/P)	Good

Possible Solutions:

Remove & Replace Entire Ramp.

Total Cost: \$ 1850.00
