# Access Compliance Report

## Public Rights-of-Way

| Intersection ID: 17170 | Main Street: MONROE_RD | Cross Street: BAINBRIDGE_RD | Location: SW |
| ADA ID: F182AB57F560 | Ramp Type: BlendTrans1 | Initial Pass/Fail: Fail | Overall Compliance: No |

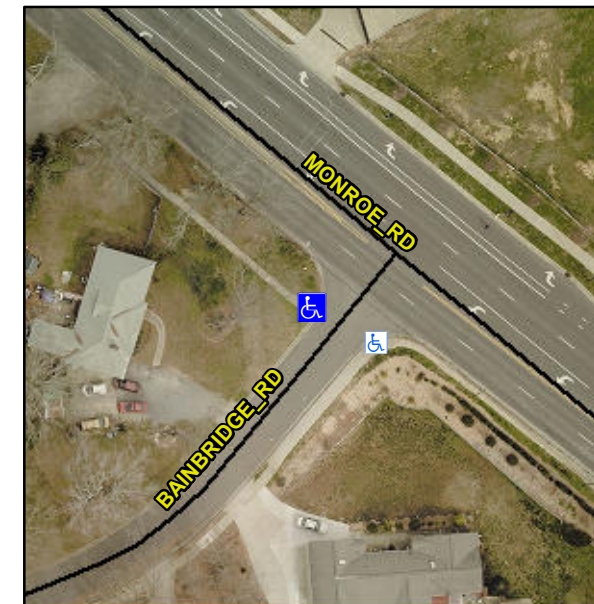
**ASP LIP 1.0**

**Not Found, R304.5.1, R304.5.3**

| Compliance | Description | Data | Compliance | Description | Data |
|---|---|---|---|---|---|
| No | Ramp Width (in) | 35.0 | No | BlendTrans XSlope (%) | 6.8 |

**Remove & Replace Curb Ramp With Two New Directional Ramps or Equivalent.**

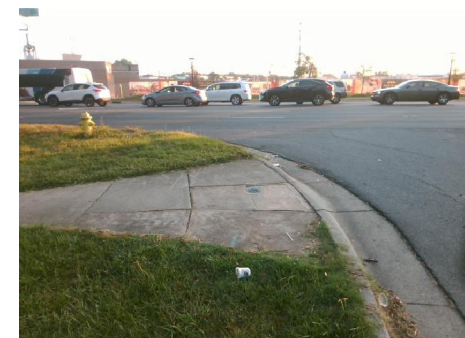
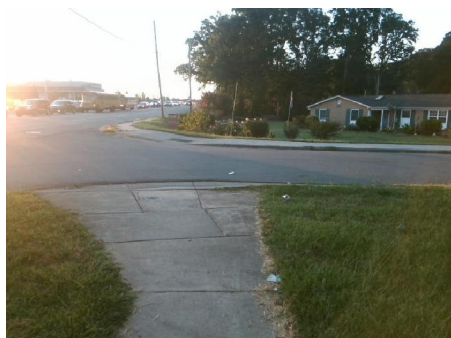
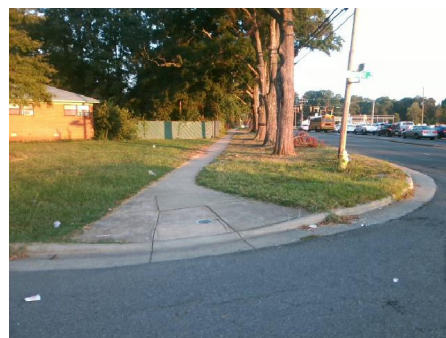
| | | Severity Score: 30 | |
