Access Compliance Report

Public Rights-of-Way

(Curb Ramps)

Intersection ID: N/A	Main Street: S_CLARKSON_ST	Cross Street: DUNBAR_ST	Location: E
ADA ID: F18551FB6A91	Ramp Type: Perp	Initial Pass/Fail: Fail	Overall Compliance: No
Severity Score: 21.25			
Codes/Mitigation Info/Possible Solution		Field Measurements/Component Compliance

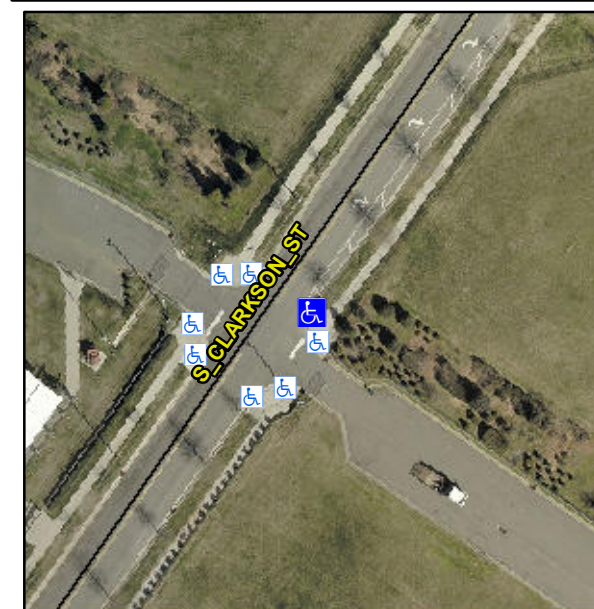
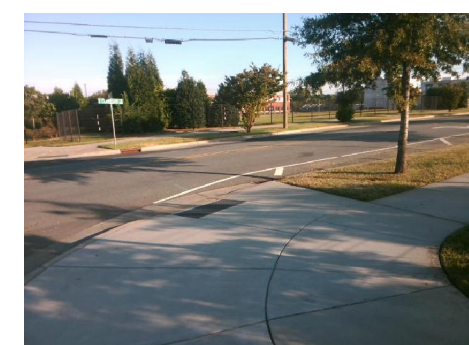
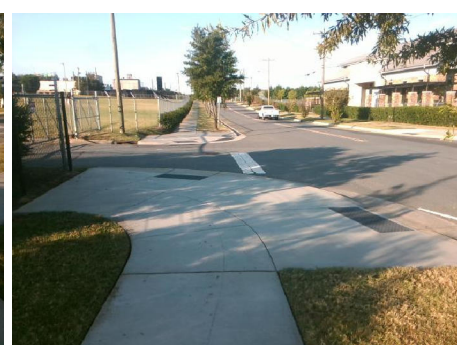
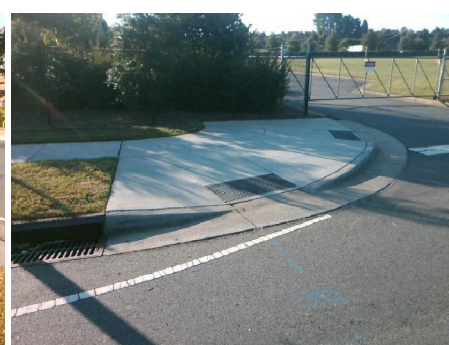
Not Found, R304.5.1, R304.2.2

Compliance	Description	Data	Compliance	Description	Data
N/A	Ramp Length (in)	95.0	No	Ramp Slope (%)	8.7
No	Ramp Width (in)	47.0	Yes	Ramp XSlope (%)	0.4
N/A	Flare Type LT	N/A	N/A	Flare Type RT	N/A
N/A	Flare Slope LT (%)	N/A	N/A	Flare Slope RT (%)	N/A
N/A	Flare Traversable LT?	N/A	N/A	Flare Traversable RT?	N/A
N/A	Landing Length (in)	N/A	N/A	DWS Provided?	N/A
N/A	Landing Width (in)	N/A	N/A	DWS Contrast?	N/A
N/A	Landing Slope (%)	N/A	N/A	DWS Length (in)	N/A
N/A	Landing X Slope (%)	N/A	N/A	DWS Full Width?	N/A
N/A	Landing Curb? (Y/N)	N/A	N/A	DWS Offset (in)	N/A
N/A	Shared Landing?	N/A			
N/A	Gutter Ponding?	N/A	N/A	Gutter Slope (%)	N/A
N/A	Gutter Lip Ht (in)	N/A	N/A	Gutter X Slope (%)	N/A
N/A	Painted X Walk1?	No	N/A	Painted X Walk2?	N/A
	X Walk 1 Direction	To NW		X Walk 2 Direction	N/A
N/A	X Walk 1 Width (in)	N/A	N/A	X Walk 2 Width (in)	N/A
	X Walk 1 Slope (%)	1.8		X Walk 2 Slope (%)	N/A
	X Walk 1 X Slope (%)	0.7		X Walk 2 X Slope (%)	N/A

N/A	Ramp inside XWalk1?	N/A	N/A	Ramp inside XWalk2?	N/A
	Road Slope (%)	N/A	N/A	Clear Space?	N/A
	Road X Slope (%)	N/A	N/A	Clear Space to XWalk (in)	N/A
N/A	Any Obstructions?	N/A	N/A	Storm Grate/Utility Hazard?	N/A
	Obstruction Type			Storm Grate/Utility Type	
		N/A			N/A
			Yes	Surface Condition? (G/P)	Good

Possible Solutions:

Remove & Replace Entire Ramp.
