Access Compliance Report

Public Rights-of-Way

(Curb Ramps)

Intersection ID: 28361	Main Street: CASTLEBAY_DR	Cross Street: TONAWANDA_DR	Location: N
ADA ID: F1858F34B2EB	Ramp Type: Perp	Initial Pass/Fail: Fail	Overall Compliance: No
Severity Score: 21.25			
Codes/Mitigation Info/Possible Solution		Field Measurements/Component Compliance

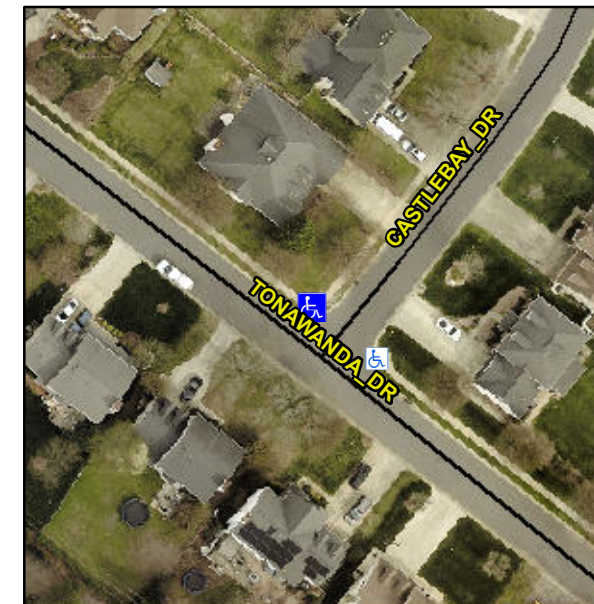
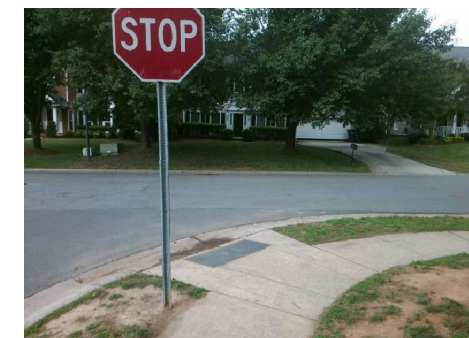
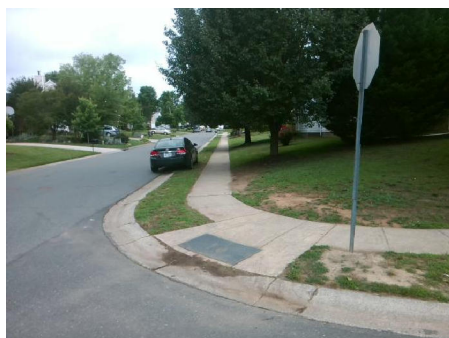
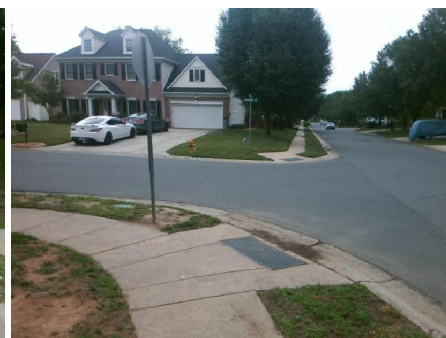
R304.5.1, R304.2.2

Compliance	Description	Data	Compliance	Description	Data
N/A	Ramp Length (in)	44.0	No	Ramp Slope (%)	8.5
No	Ramp Width (in)	45.0	Yes	Ramp XSlope (%)	1.9
N/A	Flare Type LT	N/A	N/A	Flare Type RT	N/A
N/A	Flare Slope LT (%)	N/A	N/A	Flare Slope RT (%)	N/A
N/A	Flare Traversable LT?	N/A	N/A	Flare Traversable RT?	N/A
N/A	Landing Length (in)	N/A	N/A	DWS Provided?	N/A
N/A	Landing Width (in)	N/A	N/A	DWS Contrast?	N/A
N/A	Landing Slope (%)	N/A	N/A	DWS Length (in)	N/A
N/A	Landing X Slope (%)	N/A	N/A	DWS Full Width?	N/A
N/A	Landing Curb? (Y/N)	N/A	N/A	DWS Offset (in)	N/A
N/A	Shared Landing?	N/A			
N/A	Gutter Ponding?	N/A	N/A	Gutter Slope (%)	N/A
N/A	Gutter Lip Ht (in)	0.5	N/A	Gutter X Slope (%)	N/A
N/A	Painted X Walk1?	No	N/A	Painted X Walk2?	N/A
	X Walk 1 Direction	To SW		X Walk 2 Direction	N/A
N/A	X Walk 1 Width (in)	N/A	N/A	X Walk 2 Width (in)	N/A
	X Walk 1 Slope (%)	2.3		X Walk 2 Slope (%)	N/A
	X Walk 1 X Slope (%)	1.4		X Walk 2 X Slope (%)	N/A

N/A	Ramp inside XWalk1?	N/A	N/A	Ramp inside XWalk2?	N/A
	Road Slope (%)	0.4	N/A	Clear Space?	N/A
	Road X Slope (%)	0.0	N/A	Clear Space to XWalk (in)	N/A
N/A	Any Obstructions?	N/A	N/A	Storm Grate/Utility Hazard?	N/A
	Obstruction Type			Storm Grate/Utility Type	
		N/A			N/A
			Yes	Surface Condition? (G/P)	Good

Remove & Replace Entire Ramp.

Total Cost: \$ 1850.00
