# Access Compliance Report

## Public Rights-of-Way

### (Curb Ramps)

Intersection ID: 20047	Main Street: SHARON_RD	Cross Street: MORRISON_BV	Location: W
ADA ID: F18A625490D9	Ramp Type: PerpDiag	Initial Pass/Fail: Fail	Overall Compliance: No
		Severity Score: 22.5

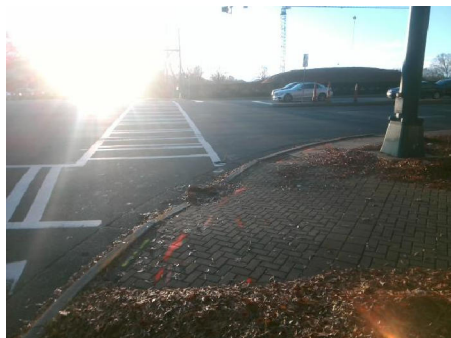
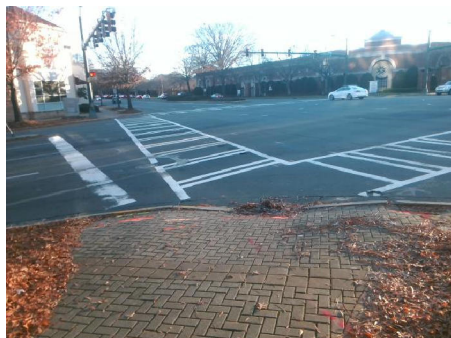
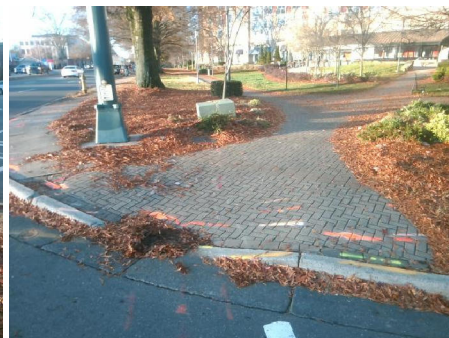
Compliance	Description	Data	Compliance	Description	Data
N/A	Ramp Length (in)	89.0	No	Ramp Slope (%)	10.0
No	Ramp Width (in)	45.0	No	Ramp XSlope (%)	4.3
N/A	Flare Type LT	N/A	N/A	Flare Type RT	N/A
N/A	Flare Slope LT (%)	N/A	N/A	Flare Slope RT (%)	N/A
N/A	Flare Traversable LT?	N/A	N/A	Flare Traversable RT?	N/A
N/A	Landing Length (in)	N/A	N/A	DWS Provided?	N/A
N/A	Landing Width (in)	N/A	N/A	DWS Contrast?	N/A
N/A	Landing Slope (%)	N/A	N/A	DWS Length (in)	N/A
N/A	Landing X Slope (%)	N/A	N/A	DWS Full Width?	N/A
N/A	Landing Curb? (Y/N)	N/A	N/A	DWS Offset (in)	N/A
N/A	Shared Landing?	N/A			
N/A	Gutter Ponding?	N/A	N/A	Gutter Slope (%)	N/A
N/A	Gutter Lip Ht (in)	N/A	N/A	Gutter X Slope (%)	N/A
N/A	Painted X Walk1?	Yes	N/A	Painted X Walk2?	Yes
	X Walk 1 Direction	To SE		X Walk 2 Direction	To NE
N/A	X Walk 1 Width (in)	106.0	N/A	X Walk 2 Width (in)	112.0
	X Walk 1 Slope (%)	4.2		X Walk 2 Slope (%)	2.1
	X Walk 1 X Slope (%)	0.3		X Walk 2 X Slope (%)	4.9

N/A	Ramp inside XWalk1?	Yes	N/A	Ramp inside XWalk2?	Yes
	Road Slope (%)	3.4	N/A	Clear Space?	N/A
	Road X Slope (%)	3.2	N/A	Clear Space to XWalk (in)	N/A
N/A	Any Obstructions?	N/A	N/A	Storm Grate/Utility Hazard?	N/A
	Obstruction Type			Storm Grate/Utility Type	
		N/A			N/A
		Yes		Surface Condition? (G/P)	Good

**Remove & Replace Curb Ramp With Two New Directional Ramps or Equivalent.**
