# Access Compliance Report

## Public Rights-of-Way

### (Curb Ramps)

| ADA ID: F18FEB90417B | Ramp Type: PerpDiag | Initial Pass/Fail: Fail | Overall Compliance: No |

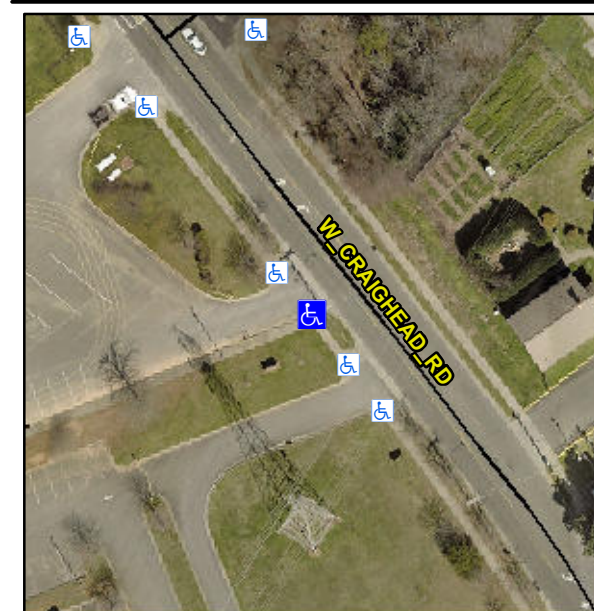
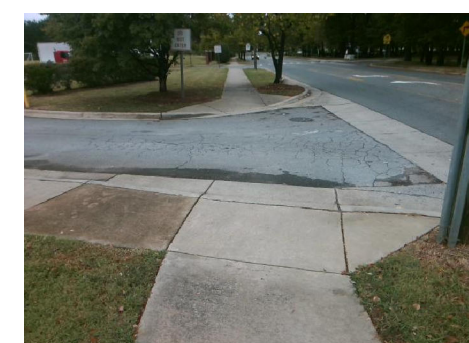
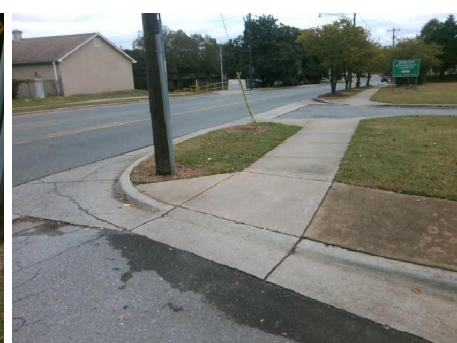
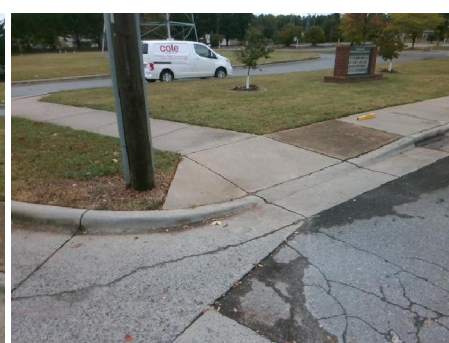
**Not Found, R304.2.2, R304.5.3**

| Compliance | Description | Data | Compliance | Description | Data |
|---|---|---|---|---|---|
| N/A | Ramp Length (in) | 60.0 | No | Ramp Slope (%) | 8.7 |
| Yes | Ramp Width (in) | 61.0 | No | Ramp XSlope (%) | 4.0 |

**Remove & Replace Curb Ramp With Two New Directional Ramps or Equivalent.**

Total Cost: \$ 3200.00
