# Access Compliance Report

## Public Rights-of-Way

### (Curb Ramps)

Intersection ID: 46033	Main Street: DOMINION_VILLAGE_DR	Cross Street: SUMMER_VALLEY_CT	Location: SW
ADA ID: F19FBA50D49D	Ramp Type: PerpDiag	Initial Pass/Fail: Fail	Overall Compliance: No
Severity Score: 10			
Codes/Mitigation Info/Possible Solution		Field Measurements/Component Compliance

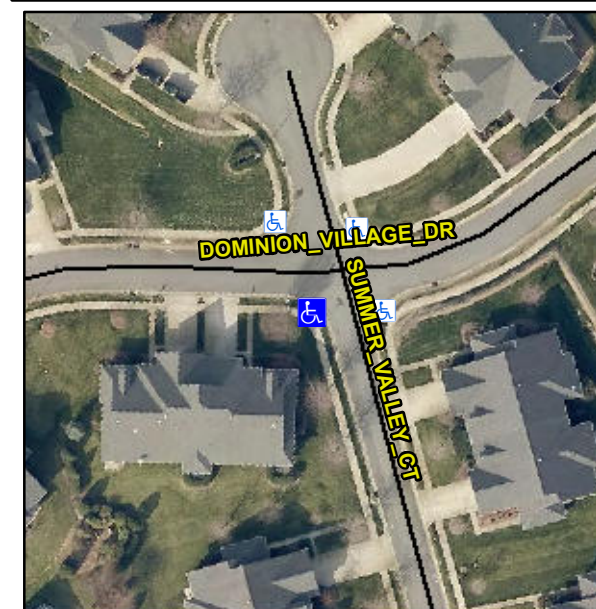
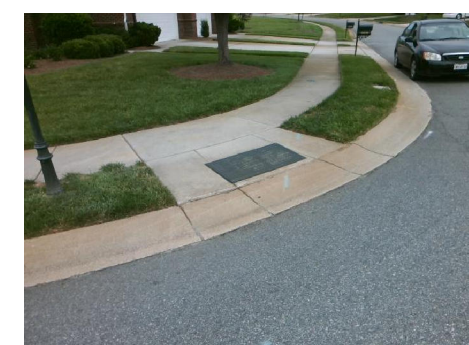
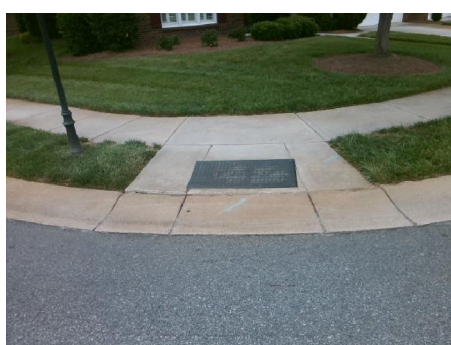
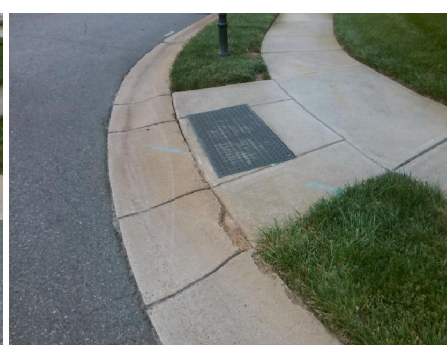
**Not Found, R304.5.1, R304.5.3**

Compliance	Description	Data	Compliance	Description	Data
N/A	Ramp Length (in)	48.0	Yes	Ramp Slope (%)	5.9
No	Ramp Width (in)	38.0	No	Ramp XSlope (%)	2.7
N/A	Flare Type LT	N/A	N/A	Flare Type RT	N/A
N/A	Flare Slope LT (%)	N/A	N/A	Flare Slope RT (%)	N/A
N/A	Flare Traversable LT?	N/A	N/A	Flare Traversable RT?	N/A
N/A	Landing Length (in)	N/A	N/A	DWS Provided?	N/A
N/A	Landing Width (in)	N/A	N/A	DWS Contrast?	N/A
N/A	Landing Slope (%)	N/A	N/A	DWS Length (in)	N/A
N/A	Landing X Slope (%)	N/A	N/A	DWS Full Width?	N/A
N/A	Landing Curb? (Y/N)	N/A	N/A	DWS Offset (in)	N/A
N/A	Shared Landing?	N/A			
N/A	Gutter Ponding?	N/A	N/A	Gutter Slope (%)	N/A
N/A	Gutter Lip Ht (in)	N/A	N/A	Gutter X Slope (%)	N/A
N/A	Painted X Walk1?	No	N/A	Painted X Walk2?	No
	X Walk 1 Direction	To E		X Walk 2 Direction	To N
N/A	X Walk 1 Width (in)	N/A	N/A	X Walk 2 Width (in)	N/A
	X Walk 1 Slope (%)	9.0		X Walk 2 Slope (%)	7.2
	X Walk 1 X Slope (%)	11.6		X Walk 2 X Slope (%)	8.4

N/A	Ramp inside XWalk1?	N/A	N/A	Ramp inside XWalk2?	N/A
	Road Slope (%)	4.0	N/A	Clear Space?	N/A
	Road X Slope (%)	11.3	N/A	Clear Space to XWalk (in)	N/A
N/A	Any Obstructions?	N/A	N/A	Storm Grate/Utility Hazard?	N/A
	Obstruction Type			Storm Grate/Utility Type	
		N/A			N/A
			Yes	Surface Condition? (G/P)	Good

**Remove & Replace Curb Ramp With Two New Directional Ramps or Equivalent.**
