# Access Compliance Report

## Public Rights-of-Way

### (Curb Ramps)

| Intersection ID: 53776 | Main Street: ELEANOR_RIGBY_RD | Cross Street: CHAPECLANE_RD | Location: SW |

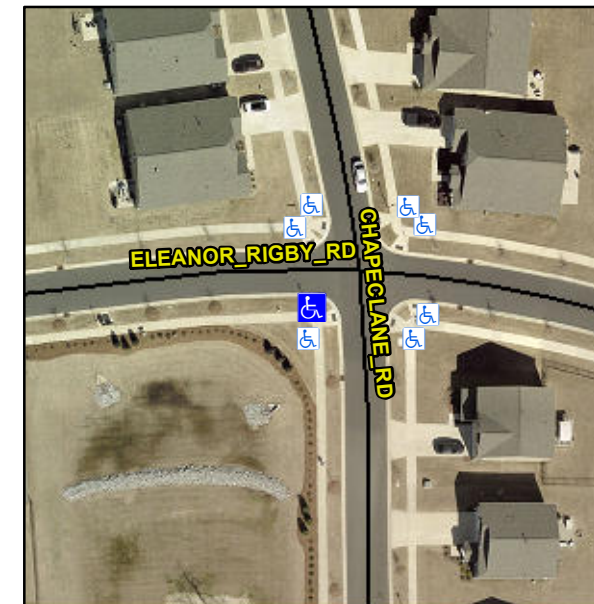
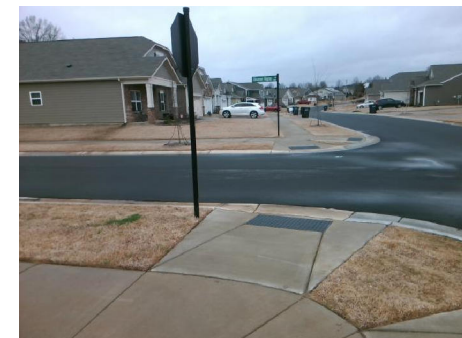
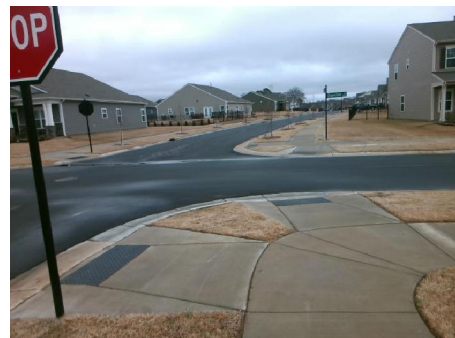
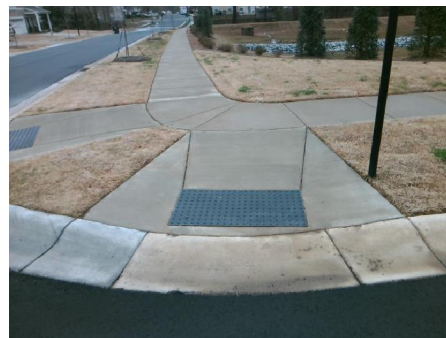
| ADA ID: F1B9DBA29737 | Ramp Type: BlendTrans1 | Initial Pass/Fail: Fail | Overall Compliance: No |
| | | Severity Score: 1.25 | |

**Not Found, R304.5.3**

| Compliance | Description | Data | Compliance | Description | Data |
|---|---|---|---|---|---|
| Yes | Ramp Width (in) | 48.0 | No | BlendTrans XSlope (%) | 3.9 |
| | | | No | Curb Slope (%) | 5.8 |

**Remove & Replace Curb Ramp With Two New Directional Ramps or Equivalent.**

Total Cost: \$ 3200.00
