# Access Compliance Report

## Public Rights-of-Way

### (Curb Ramps)

Intersection ID: 43533	Main Street: REDSPIRE_DR	Cross Street: PLANTERS_WATCH_DR	Location: SW
ADA ID: F1CDBDEE3399	Ramp Type: PerpDiag	Initial Pass/Fail: Fail	Overall Compliance: No
Severity Score: 8.75			
Codes/Mitigation Info/Possible Solution		Field Measurements/Component Compliance

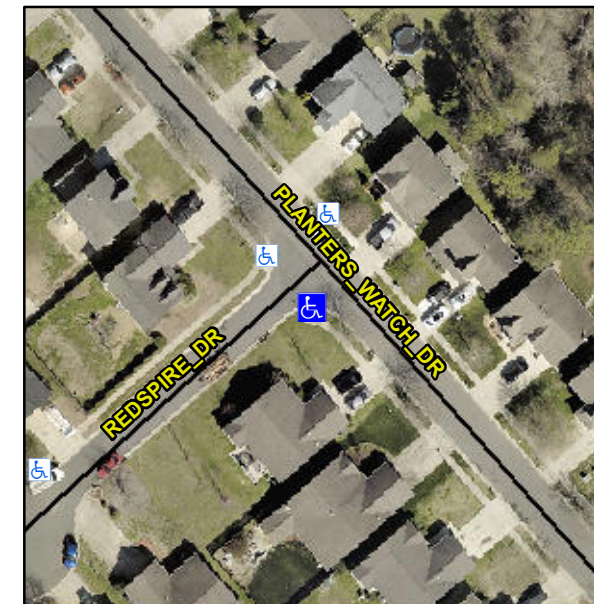
Compliance	Description	Data	Compliance	Description	Data
N/A	Ramp Length (in)	50.0	Yes	Ramp Slope (%)	5.7
No	Ramp Width (in)	40.0	Yes	Ramp XSlope (%)	0.4
N/A	Flare Type LT	N/A	N/A	Flare Type RT	N/A
N/A	Flare Slope LT (%)	N/A	N/A	Flare Slope RT (%)	N/A
N/A	Flare Traversable LT?	N/A	N/A	Flare Traversable RT?	N/A
N/A	Landing Length (in)	N/A	N/A	DWS Provided?	N/A
N/A	Landing Width (in)	N/A	N/A	DWS Contrast?	N/A
N/A	Landing Slope (%)	N/A	N/A	DWS Length (in)	N/A
N/A	Landing X Slope (%)	N/A	N/A	DWS Full Width?	N/A
N/A	Landing Curb? (Y/N)	N/A	N/A	DWS Offset (in)	N/A
N/A	Shared Landing?	N/A			
N/A	Gutter Ponding?	N/A	N/A	Gutter Slope (%)	N/A
N/A	Gutter Lip Ht (in)	N/A	N/A	Gutter X Slope (%)	N/A
N/A	Painted X Walk1?	No	N/A	Painted X Walk2?	No
	X Walk 1 Direction	To NE		X Walk 2 Direction	To NW
N/A	X Walk 1 Width (in)	N/A	N/A	X Walk 2 Width (in)	N/A
	X Walk 1 Slope (%)	0.8		X Walk 2 Slope (%)	0.4
	X Walk 1 X Slope (%)	1.5		X Walk 2 X Slope (%)	2.3

N/A	Ramp inside XWalk1?	N/A	N/A	Ramp inside XWalk2?	N/A
	Road Slope (%)	1.1	N/A	Clear Space?	N/A
	Road X Slope (%)	2.8	N/A	Clear Space to XWalk (in)	N/A
N/A	Any Obstructions?	N/A	N/A	Storm Grate/Utility Hazard?	N/A
	Obstruction Type			Storm Grate/Utility Type	
		N/A			N/A
			Yes	Surface Condition? (G/P)	Good

Possible Solutions:

**Remove & Replace Curb Ramp With Two New Directional Ramps or Equivalent.**

**R304.5.1**
