Access Compliance Report

Public Rights-of-Way

(Curb Ramps)

Intersection ID: 53436	Main Street: MARSHALL_BRIDGE_RD	Cross Street: WALNUT_LOOP_RD	Location: NW
ADA ID: F1D0A2A2E53D	Ramp Type: Perp	Initial Pass/Fail: Fail	Overall Compliance: No
Severity Score: 12.5			
Codes/Mitigation Info/Possible Solution		Field Measurements/Component Compliance

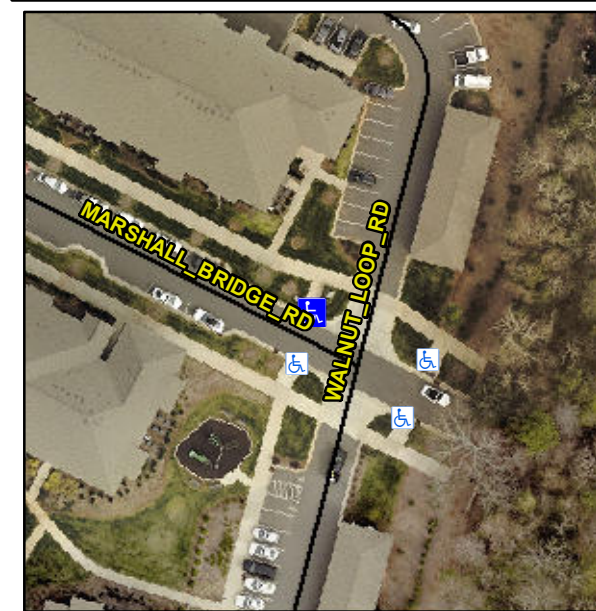
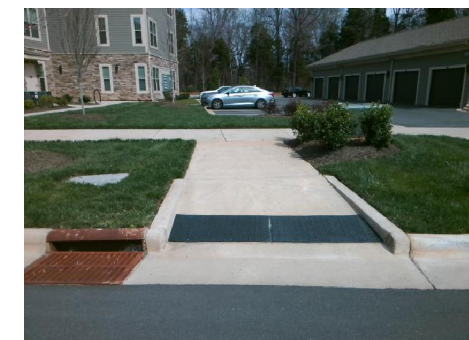
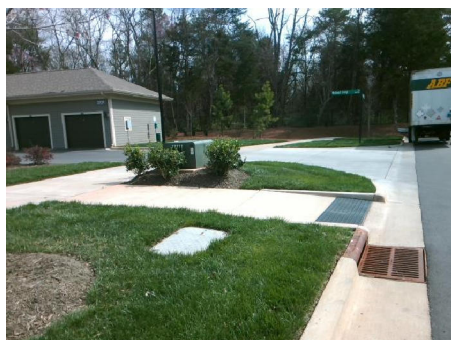
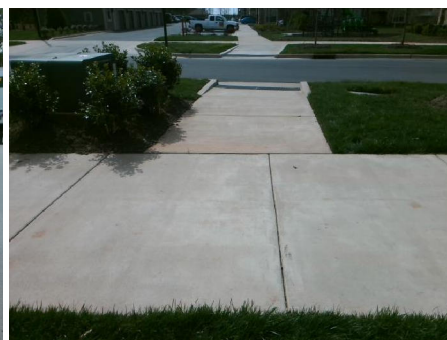
Not Found, R304.2.2

Compliance	Description	Data	Compliance	Description	Data
N/A	Ramp Length (in)	72.0	No	Ramp Slope (%)	8.4
Yes	Ramp Width (in)	81.5	Yes	Ramp XSlope (%)	0.6
N/A	Flare Type LT	N/A	N/A	Flare Type RT	N/A
N/A	Flare Slope LT (%)	N/A	N/A	Flare Slope RT (%)	N/A
N/A	Flare Traversable LT?	N/A	N/A	Flare Traversable RT?	N/A
N/A	Landing Length (in)	N/A	N/A	DWS Provided?	N/A
N/A	Landing Width (in)	N/A	N/A	DWS Contrast?	N/A
N/A	Landing Slope (%)	N/A	N/A	DWS Length (in)	N/A
N/A	Landing X Slope (%)	N/A	N/A	DWS Full Width?	N/A
N/A	Landing Curb? (Y/N)	N/A	N/A	DWS Offset (in)	N/A
N/A	Shared Landing?	N/A			
N/A	Gutter Ponding?	N/A	N/A	Gutter Slope (%)	N/A
N/A	Gutter Lip Ht (in)	N/A	N/A	Gutter X Slope (%)	N/A
N/A	Painted X Walk1?	No	N/A	Painted X Walk2?	N/A
	X Walk 1 Direction	To W		X Walk 2 Direction	N/A
N/A	X Walk 1 Width (in)	N/A	N/A	X Walk 2 Width (in)	N/A
	X Walk 1 Slope (%)	1.7		X Walk 2 Slope (%)	N/A
	X Walk 1 X Slope (%)	0.4		X Walk 2 X Slope (%)	N/A

Remove & Replace Entire Ramp.
