# Access Compliance Report

## Public Rights-of-Way

### (Curb Ramps)

| Intersection ID: 52226 | Main Street: AMESBURY_HILL_DR | Cross Street: AUBURN_HILL_LN | Location: NW |

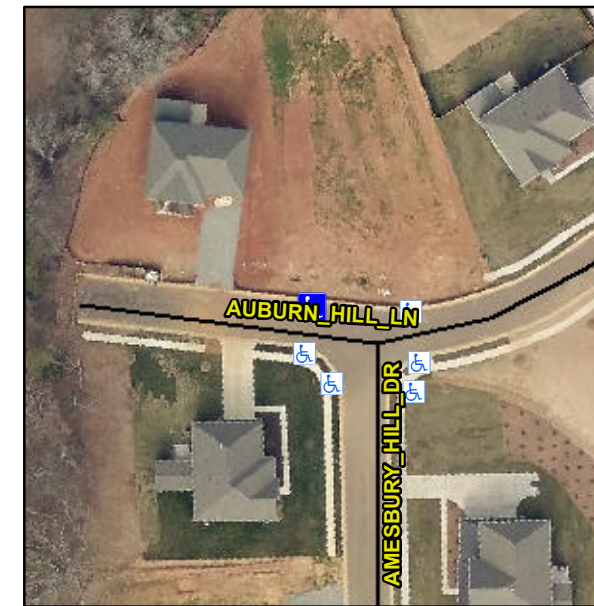
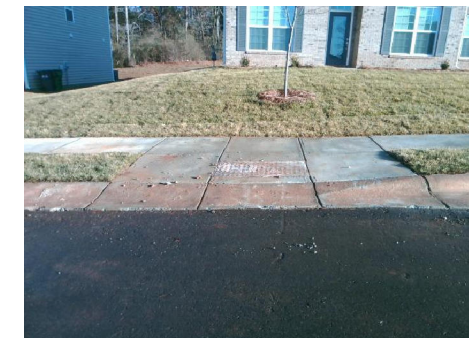
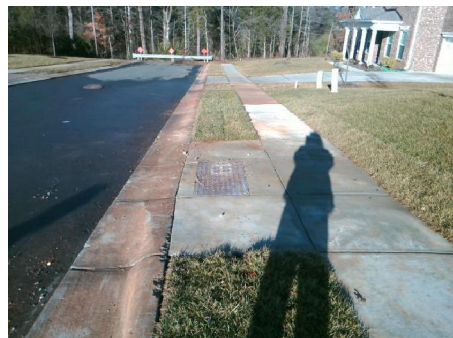
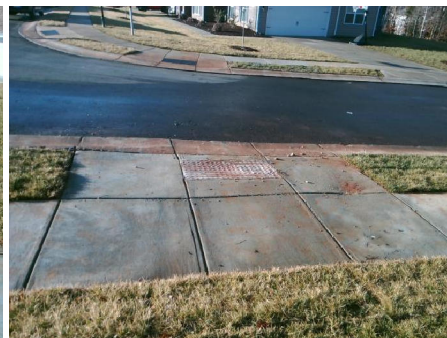
| ADA ID: F1DF5E254569 | Ramp Type: Perp | Initial Pass/Fail: Fail | Overall Compliance: No |

| | | Severity Score: 10 | |

**Not Found, R304.5.1**

| Compliance | Description | Data | Compliance | Description | Data |
|---|---|---|---|---|---|
| No | Ramp Width (in) | 47.0 | Yes | Ramp XSlope (%) | 4.7 |

**Remove & Replace Entire Ramp.**

Total Cost: \$ 1850.00
