Access Compliance Report

Public Rights-of-Way

(Curb Ramps)

Intersection ID: 14833	Main Street: ALBEMARLE_RD	Cross Street: MARTIN_LAKE_RD	Location:	S
ADA ID: F1DF7ED96411	Ramp Type: Perp	Initial Pass/Fail: Fail	Overall Compliance: No	Severity Score: 12.5
Codes/Mitigation Info/Possible Solution		Field Measurements/Component Compliance

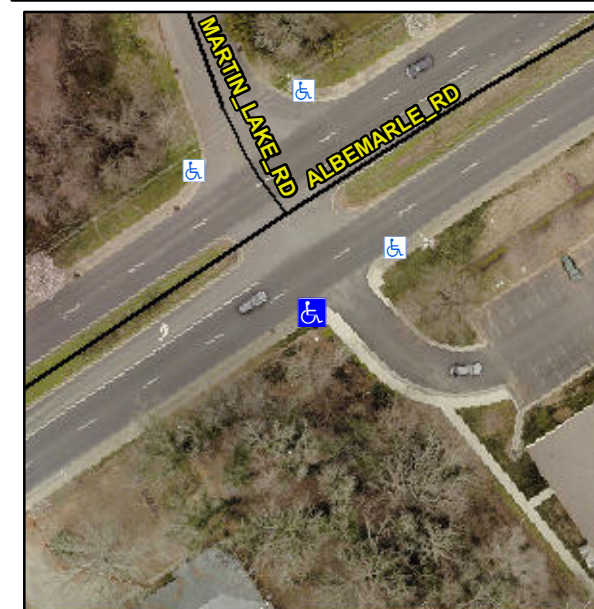
Compliance	Description	Data	Compliance	Description	Data
N/A	Ramp Length (in)	63.0	No	Ramp Slope (%)	8.7
Yes	Ramp Width (in)	48.0	Yes	Ramp XSlope (%)	1.8
N/A	Flare Type LT	N/A	N/A	Flare Type RT	N/A
N/A	Flare Slope LT (%)	N/A	N/A	Flare Slope RT (%)	N/A
N/A	Flare Traversable LT?	N/A	N/A	Flare Traversable RT?	N/A
N/A	Landing Length (in)	N/A	N/A	DWS Provided?	N/A
N/A	Landing Width (in)	N/A	N/A	DWS Contrast?	N/A
N/A	Landing Slope (%)	N/A	N/A	DWS Length (in)	N/A
N/A	Landing X Slope (%)	N/A	N/A	DWS Full Width?	N/A
N/A	Landing Curb? (Y/N)	N/A	N/A	DWS Offset (in)	N/A
N/A	Shared Landing?	N/A			
N/A	Gutter Ponding?	N/A	N/A	Gutter Slope (%)	N/A
N/A	Gutter Lip Ht (in)	N/A	N/A	Gutter X Slope (%)	N/A
N/A	Painted X Walk1?	No	N/A	Painted X Walk2?	N/A
	X Walk 1 Direction	To N		X Walk 2 Direction	N/A
N/A	X Walk 1 Width (in)	N/A	N/A	X Walk 2 Width (in)	N/A
	X Walk 1 Slope (%)	3.2		X Walk 2 Slope (%)	N/A
	X Walk 1 X Slope (%)	1.0		X Walk 2 X Slope (%)	N/A

N/A	Ramp inside XWalk1?	N/A	N/A	Ramp inside XWalk2?	N/A
	Road Slope (%)	N/A	N/A	Clear Space?	N/A
	Road X Slope (%)	N/A	N/A	Clear Space to XWalk (in)	N/A
N/A	Any Obstructions?	N/A	N/A	Storm Grate/Utility Hazard?	N/A
	Obstruction Type			Storm Grate/Utility Type	
		N/A			N/A
			Yes	Surface Condition? (G/P)	Good

Possible Solutions:

Remove & Replace Entire Ramp.
