Access Compliance Report

Public Rights-of-Way

(Curb Ramps)

Intersection ID: 11259	Main Street: CONNECTICUT_AV	Cross Street: SPRINGWAY_DR	Location: NE
ADA ID: F1E4AA7FABE7	Ramp Type: Perp	Initial Pass/Fail: Fail	Overall Compliance: No
			Severity Score: 33.75

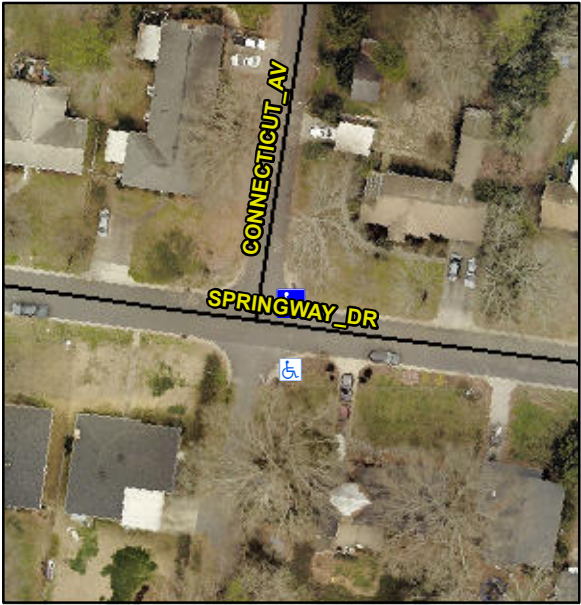
Possible Solutions:		Compliance	Description	Data
	Remove & Replace Entire Ramp.		No	Ramp Length (in)	61.0
			No	Ramp Width (in)	45.5
			N/A	Flare Type LT	N/A
			N/A	Flare Slope LT (%)	N/A
			N/A	Flare Traversable LT?	N/A
			N/A	Landing Length (in)	N/A
			N/A	Landing Width (in)	N/A
			N/A	Landing Slope (%)	N/A
			N/A	Landing X Slope (%)	N/A
<p>Surveyor Notes:</p> <p>N/A</p> <p>PROW/ADA:</p> <p>Not Found, R304.5.1, R304.2.2, R304.5.3</p>			N/A	Flare Type RT	N/A
			N/A	Flare Slope RT (%)	N/A
			N/A	Flare Traversable RT?	N/A
			N/A	DWS Provided?	N/A
			N/A	DWS Contrast?	N/A
			N/A	DWS Length (in)	N/A
			N/A	DWS Full Width?	N/A
			N/A	DWS Offset (in)	N/A
			N/A	Shared Landing?	N/A
			N/A	Gutter Ponding?	N/A
			N/A	Gutter Lip Ht (in)	N/A
			N/A	Painted X Walk1?	No
				X Walk 1 Direction	To S
			N/A	X Walk 1 Width (in)	N/A
				X Walk 1 Slope (%)	5.9

X Walk 1 X Slope (%)	2.8
			N/A	Ramp inside XWalk1?	N/A
			N/A	Road Slope (%)	N/A
			N/A	Road X Slope (%)	N/A
			N/A	Any Obstructions?	N/A
Total Cost:		\$ 1850.00		Obstruction Type	
			N/A		
			N/A	Storm Grate/Utility Hazard?	N/A
				Storm Grate/Utility Type	
			N/A		N/A
			Yes	Surface Condition? (G/P)	Good
