# Access Compliance Report

## Public Rights-of-Way

### (Curb Ramps)

Intersection ID: 14294	Main Street: EAST_BV	Cross Street: EUCLID_AV	Location: NE
ADA ID: F1F06BADE824	Ramp Type: Directional1	Initial Pass/Fail: Pass	Overall Compliance: No
Codes/Mitigation Info/Possible Solution		Field Measurements/Component Compliance	
Severity Score: 0.25

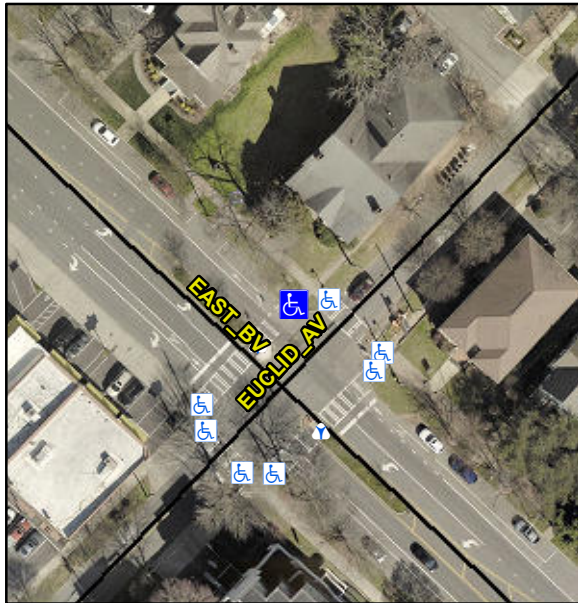
**LNDG SLOPE NEGATIVE**

**R304.2.2-Perp, R304.3.2-Para**

Compliance	Description	Data	Compliance	Description	Data
N/A	Ramp Length (in)	70.0	Yes	Grade Break?	Yes
Yes	Ramp Width (in)	72.0	Yes	Grade Break Slope (%)	1.3
Yes	Ramp Slope (%)	2.7	Yes	Grade Break XSlope (%)	2.3
Yes	Ramp XSlope (%)	2.9			
Yes	Flare Type LT	N/A	Yes	Flare Type RT	N/A
N/A	Flare Slope LT (%)	N/A	N/A	Flare Slope RT (%)	N/A
N/A	Flare Traversable LT?	No	N/A	Flare Traversable RT?	No
Yes	Landing Length (in)	69.0	Yes	DWS Provided?	Yes
Yes	Landing Width (in)	72.0	Yes	DWS Contrast?	Yes
No	Landing Slope (%)	4.6	Yes	DWS Length (in)	25.0
Yes	Landing X Slope (%)	2.0	Yes	DWS Full Width?	Yes
N/A	Landing Curb? (Y/N)	No	Yes	DWS Offset LT (in)	22.0
N/A	Shared Landing?	No	Yes	DWS Offset RT (in)	0.0
Yes	Gutter Ponding?	No	Yes	Gutter Slope (%)	0.7
Yes	Gutter Lip Ht (in)	0.0	Yes	Gutter X Slope (%)	2.9
N/A	Painted X Walk1?	Yes		Road Slope (%)	1.5
	X Walk 1 Direction	To SW		Road X Slope (%)	3.2
	X Walk 1 Width (in)	112.0		Clear Space?	Yes

X Walk 1 Slope (%)	1.5	N/A	Clear Space to XWalk (in)	N/A
	X Walk 1 X Slope (%)	3.2	Yes	Storm Grate/Utility Hazard?	No
Yes	Ramp inside XWalk1?	Yes		Storm Grate/Utility Type	
Yes	Any Obstructions?	No			N/A
	Obstruction Type		Yes	Surface Condition? (G/P)	Good
			N/A	Curb Slope (%)	1.7

Possible Solutions:

**Remove & Replace Landing.**
