# Access Compliance Report

## Public Rights-of-Way

### (Curb Ramps)

Intersection ID: 12937	Main Street: E_W_T_HARRIS_BV	Cross Street: HICKORY_GROVE_RD	Location: NW
ADA ID: F1F23EA58B5E	Ramp Type: Perp	Initial Pass/Fail: Fail	Overall Compliance: No
		Severity Score: 25

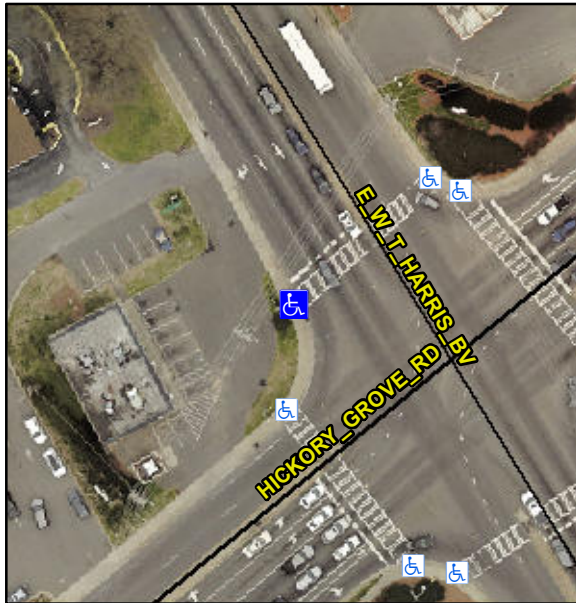
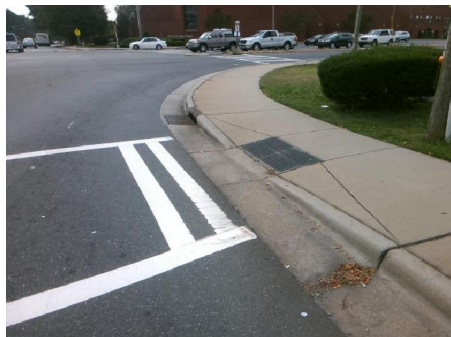
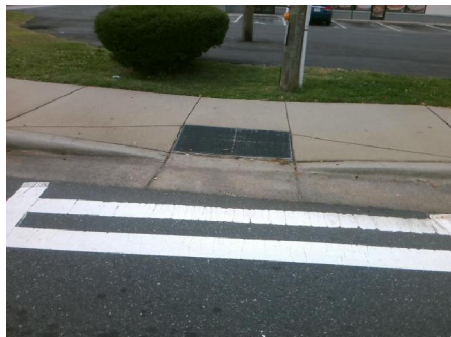
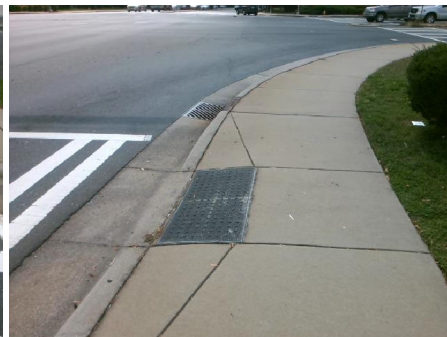
**Not Found, R304.2.2**

Compliance	Description	Data	Compliance	Description	Data
N/A	Ramp Length (in)	24.5	No	Ramp Slope (%)	15.3
Yes	Ramp Width (in)	48.0	Yes	Ramp XSlope (%)	0.1
N/A	Flare Type LT	N/A	N/A	Flare Type RT	N/A
N/A	Flare Slope LT (%)	N/A	N/A	Flare Slope RT (%)	N/A
N/A	Flare Traversable LT?	N/A	N/A	Flare Traversable RT?	N/A
N/A	Landing Length (in)	N/A	N/A	DWS Provided?	N/A
N/A	Landing Width (in)	N/A	N/A	DWS Contrast?	N/A
N/A	Landing Slope (%)	N/A	N/A	DWS Length (in)	N/A
N/A	Landing X Slope (%)	N/A	N/A	DWS Full Width?	N/A
N/A	Landing Curb? (Y/N)	N/A	N/A	DWS Offset (in)	N/A
N/A	Shared Landing?	N/A			
N/A	Gutter Ponding?	N/A	N/A	Gutter Slope (%)	N/A
N/A	Gutter Lip Ht (in)	N/A	N/A	Gutter X Slope (%)	N/A
N/A	Painted X Walk1?	Yes	N/A	Painted X Walk2?	N/A
	X Walk 1 Direction	To S		X Walk 2 Direction	N/A
N/A	X Walk 1 Width (in)	117.0	N/A	X Walk 2 Width (in)	N/A
	X Walk 1 Slope (%)	2.3		X Walk 2 Slope (%)	N/A
	X Walk 1 X Slope (%)	0.3		X Walk 2 X Slope (%)	N/A

N/A	Ramp inside XWalk1?	Yes	N/A	Ramp inside XWalk2?	N/A
	Road Slope (%)	N/A	N/A	Clear Space?	N/A
	Road X Slope (%)	N/A	N/A	Clear Space to XWalk (in)	N/A
N/A	Any Obstructions?	N/A	N/A	Storm Grate/Utility Hazard?	N/A
	Obstruction Type			Storm Grate/Utility Type	
		N/A			N/A
			Yes	Surface Condition? (G/P)	Good

**Remove & Replace Entire Ramp.**
