Access Compliance Report

Public Rights-of-Way

(Curb Ramps)

Intersection ID: 26822	Main Street: CREEK_BEND_DR	Cross Street: RIDGEMORE_DR	Location:	N
ADA ID: F1FE5C0610CB	Ramp Type: PerpDiag	Initial Pass/Fail: Fail	Overall Compliance: No	Severity Score: 22.5
Codes/Mitigation Info/Possible Solution		Field Measurements/Component Compliance

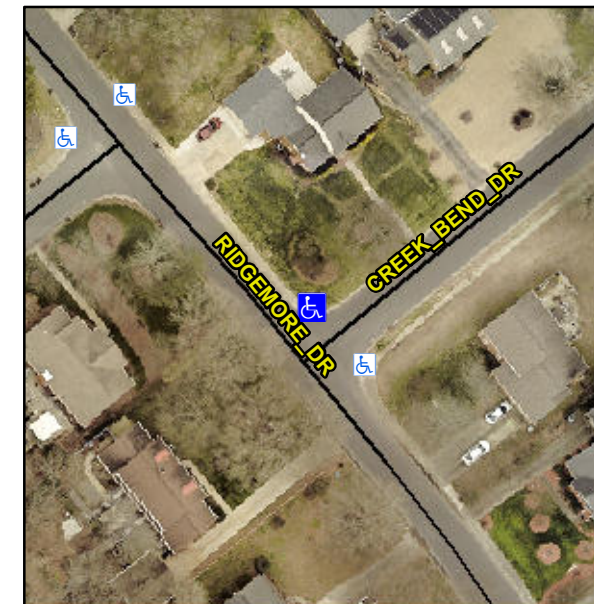
Not Found, R304.5.1, R304.2.2, R304.5.3

Compliance	Description	Data	Compliance	Description	Data
N/A	Ramp Length (in)	50.0	No	Ramp Slope (%)	8.8
No	Ramp Width (in)	38.0	No	Ramp XSlope (%)	3.0
N/A	Flare Type LT	N/A	N/A	Flare Type RT	N/A
N/A	Flare Slope LT (%)	N/A	N/A	Flare Slope RT (%)	N/A
N/A	Flare Traversable LT?	N/A	N/A	Flare Traversable RT?	N/A
N/A	Landing Length (in)	N/A	N/A	DWS Provided?	N/A
N/A	Landing Width (in)	N/A	N/A	DWS Contrast?	N/A
N/A	Landing Slope (%)	N/A	N/A	DWS Length (in)	N/A
N/A	Landing X Slope (%)	N/A	N/A	DWS Full Width?	N/A
N/A	Landing Curb? (Y/N)	N/A	N/A	DWS Offset (in)	N/A
N/A	Shared Landing?	N/A			
N/A	Gutter Ponding?	N/A	N/A	Gutter Slope (%)	N/A
N/A	Gutter Lip Ht (in)	N/A	N/A	Gutter X Slope (%)	N/A
N/A	Painted X Walk1?	No	N/A	Painted X Walk2?	No
	X Walk 1 Direction	To SW		X Walk 2 Direction	To SE
N/A	X Walk 1 Width (in)	N/A	N/A	X Walk 2 Width (in)	N/A
	X Walk 1 Slope (%)	1.1		X Walk 2 Slope (%)	1.0
	X Walk 1 X Slope (%)	0.9		X Walk 2 X Slope (%)	2.7

N/A	Ramp inside XWalk1?	N/A	N/A	Ramp inside XWalk2?	N/A
	Road Slope (%)	2.2	N/A	Clear Space?	N/A
	Road X Slope (%)	0.2	N/A	Clear Space to XWalk (in)	N/A
N/A	Any Obstructions?	N/A	N/A	Storm Grate/Utility Hazard?	N/A
	Obstruction Type			Storm Grate/Utility Type	
		N/A			N/A
			Yes	Surface Condition? (G/P)	Good

Remove & Replace Curb Ramp With Two New Directional Ramps or Equivalent.
