# Access Compliance Report

## Public Rights-of-Way

### (Curb Ramps)

Intersection ID: 47914	Main Street: MEARN_RD	Cross Street: ROOK_RD	Location: SE
ADA ID: F200B9D028A9	Ramp Type: PerpDiag	Initial Pass/Fail: Fail	Overall Compliance: No
Codes/Mitigation Info/Possible Solution		Field Measurements/Component Compliance	
Severity Score: 21.25

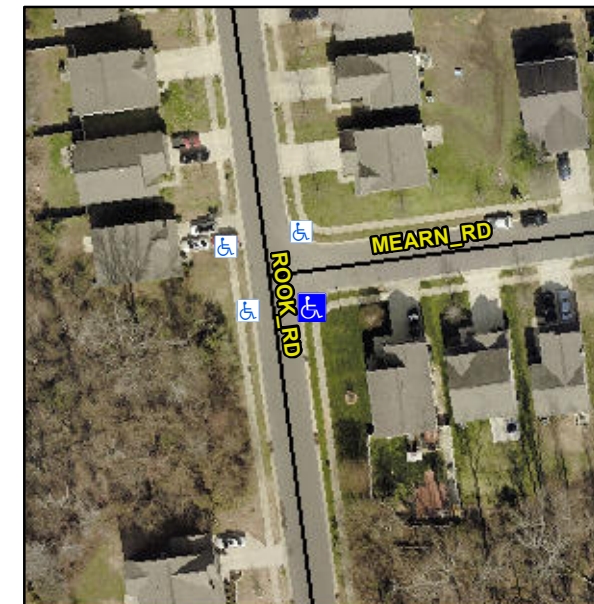
**Not Found, R304.5.1, R304.2.2**

Compliance	Description	Data	Compliance	Description	Data
N/A	Ramp Length (in)	48.0	No	Ramp Slope (%)	9.1
No	Ramp Width (in)	46.0	Yes	Ramp XSlope (%)	1.2
N/A	Flare Type LT	N/A	N/A	Flare Type RT	N/A
N/A	Flare Slope LT (%)	N/A	N/A	Flare Slope RT (%)	N/A
N/A	Flare Traversable LT?	N/A	N/A	Flare Traversable RT?	N/A
N/A	Landing Length (in)	N/A	N/A	DWS Provided?	N/A
N/A	Landing Width (in)	N/A	N/A	DWS Contrast?	N/A
N/A	Landing Slope (%)	N/A	N/A	DWS Length (in)	N/A
N/A	Landing X Slope (%)	N/A	N/A	DWS Full Width?	N/A
N/A	Landing Curb? (Y/N)	N/A	N/A	DWS Offset (in)	N/A
N/A	Shared Landing?	N/A			
N/A	Gutter Ponding?	N/A	N/A	Gutter Slope (%)	N/A
N/A	Gutter Lip Ht (in)	N/A	N/A	Gutter X Slope (%)	N/A
N/A	Painted X Walk1?	No	N/A	Painted X Walk2?	No
	X Walk 1 Direction	To N		X Walk 2 Direction	To W
N/A	X Walk 1 Width (in)	N/A	N/A	X Walk 2 Width (in)	N/A
	X Walk 1 Slope (%)	2.6		X Walk 2 Slope (%)	5.4
	X Walk 1 X Slope (%)	0.9		X Walk 2 X Slope (%)	0.8

N/A	Ramp inside XWalk1?	N/A	N/A	Ramp inside XWalk2?	N/A
	Road Slope (%)	2.5	N/A	Clear Space?	N/A
	Road X Slope (%)	4.0	N/A	Clear Space to XWalk (in)	N/A
N/A	Any Obstructions?	N/A	N/A	Storm Grate/Utility Hazard?	N/A
	Obstruction Type			Storm Grate/Utility Type	
		N/A			N/A
		Yes		Surface Condition? (G/P)	Good

**Remove & Replace Curb Ramp With Two New Directional Ramps or Equivalent.**

Total Cost: \$ 3200.00
