Access Compliance Report

Public Rights-of-Way

(Curb Ramps)

Intersection ID: 10957	Main Street: CRISMAN_ST	Cross Street: PACIFIC_ST	Location: W
ADA ID: F207B5DECD72	Ramp Type: Perp	Initial Pass/Fail: Fail	Overall Compliance: No
		Severity Score: 10

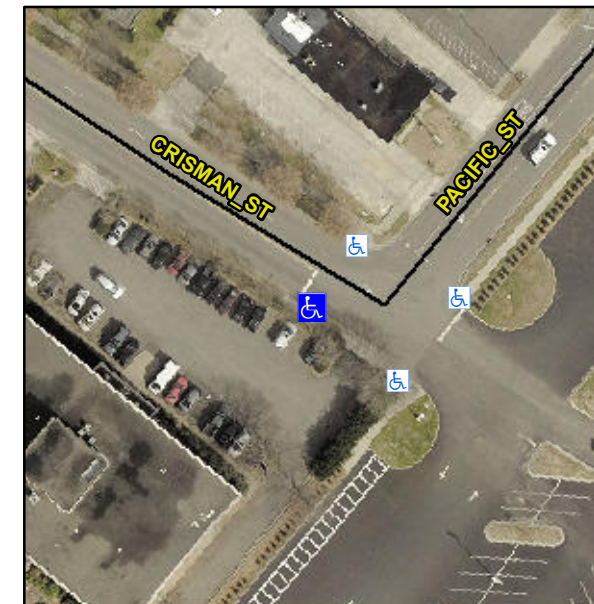
Not Found, R304.5.1, R304.5.3

Compliance	Description	Data	Compliance	Description	Data
N/A	Ramp Length (in)	73.0	Yes	Ramp Slope (%)	7.6
No	Ramp Width (in)	47.0	No	Ramp XSlope (%)	2.3
N/A	Flare Type LT	N/A	N/A	Flare Type RT	N/A
N/A	Flare Slope LT (%)	N/A	N/A	Flare Slope RT (%)	N/A
N/A	Flare Traversable LT?	N/A	N/A	Flare Traversable RT?	N/A
N/A	Landing Length (in)	N/A	N/A	DWS Provided?	N/A
N/A	Landing Width (in)	N/A	N/A	DWS Contrast?	N/A
N/A	Landing Slope (%)	N/A	N/A	DWS Length (in)	N/A
N/A	Landing X Slope (%)	N/A	N/A	DWS Full Width?	N/A
N/A	Landing Curb? (Y/N)	N/A	N/A	DWS Offset (in)	N/A
N/A	Shared Landing?	N/A			
N/A	Gutter Ponding?	N/A	N/A	Gutter Slope (%)	N/A
N/A	Gutter Lip Ht (in)	N/A	N/A	Gutter X Slope (%)	N/A
N/A	Painted X Walk1?	No	N/A	Painted X Walk2?	N/A
	X Walk 1 Direction	To NE		X Walk 2 Direction	N/A
N/A	X Walk 1 Width (in)	N/A	N/A	X Walk 2 Width (in)	N/A
	X Walk 1 Slope (%)	7.9		X Walk 2 Slope (%)	N/A
	X Walk 1 X Slope (%)	1.8		X Walk 2 X Slope (%)	N/A

N/A	Ramp inside XWalk1?	N/A	N/A	Ramp inside XWalk2?	N/A
	Road Slope (%)	N/A	N/A	Clear Space?	N/A
	Road X Slope (%)	N/A	N/A	Clear Space to XWalk (in)	N/A
N/A	Any Obstructions?	N/A	N/A	Storm Grate/Utility Hazard?	N/A
	Obstruction Type			Storm Grate/Utility Type	
		N/A			N/A
			Yes	Surface Condition? (G/P)	Good

Remove & Replace Entire Ramp.
