Access Compliance Report

Public Rights-of-Way

(Curb Ramps)

Intersection ID: 53147	Main Street: ACHIEVEMENT_LN	Cross Street: NEW_RENAISSANCE_WY	Location: W
ADA ID: F21518C17587	Ramp Type: Directional1	Initial Pass/Fail: Fail	Overall Compliance: No
		Severity Score: 1.25

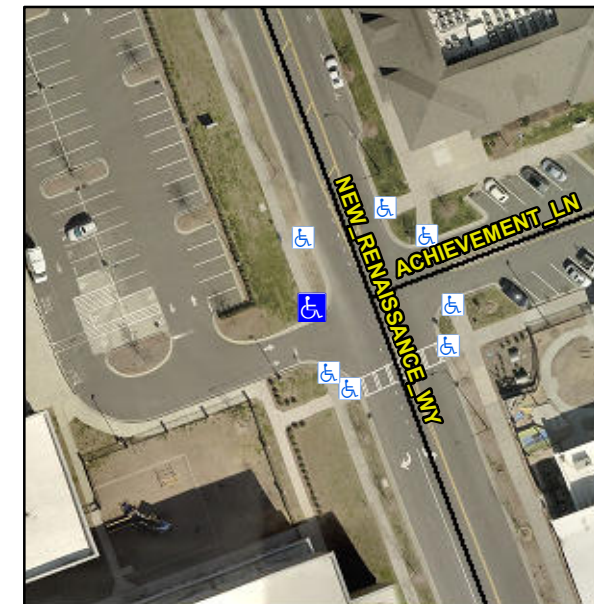
Compliance	Description	Data	Compliance	Description	Data
N/A	Ramp Length (in)	60.0	N/A	Grade Break?	N/A
Yes	Ramp Width (in)	70.0	N/A	Grade Break Slope (%)	0.0
Yes	Ramp Slope (%)	8.1	N/A	Grade Break XSlope (%)	0.0
No	Ramp XSlope (%)	3.0			
N/A	Flare Type LT	N/A	N/A	Flare Type RT	N/A
N/A	Flare Slope LT (%)	N/A	N/A	Flare Slope RT (%)	0.0
N/A	Flare Traversable LT?	N/A	N/A	Flare Traversable RT?	N/A
N/A	Landing Length (in)	0.0	N/A	DWS Provided?	N/A
N/A	Landing Width (in)	0.0	N/A	DWS Contrast?	N/A
N/A	Landing Slope (%)	0.0	N/A	DWS Length (in)	N/A
N/A	Landing X Slope (%)	0.0	N/A	DWS Full Width?	N/A
N/A	Landing Curb? (Y/N)	N/A	N/A	DWS Offset LT (in)	N/A
N/A	Shared Landing?	N/A	N/A	DWS Offset RT (in)	N/A
N/A	Gutter Ponding?	0.0	N/A	Gutter Slope (%)	N/A
N/A	Gutter Lip Ht (in)	0.0	N/A	Gutter X Slope (%)	N/A
N/A	Painted X Walk1?	No		Road Slope (%)	0.8
	X Walk 1 Direction	To SE		Road X Slope (%)	0.8
	X Walk 1 Width (in)	N/A		Clear Space?	N/A

X Walk 1 Slope (%)	0.8	N/A	Clear Space to XWalk (in)	N/A
	X Walk 1 X Slope (%)	0.8	N/A	Storm Grate/Utility Hazard?	N/A
N/A	Ramp inside XWalk1?	N/A		Storm Grate/Utility Type	
N/A	Any Obstructions?	N/A			N/A
	Obstruction Type		Yes	Surface Condition? (G/P)	Good
			N/A	Curb Slope (%)	2.4

Remove & Replace Entire Ramp.

R304.5.3
