# Access Compliance Report

## Public Rights-of-Way

### (Curb Ramps)

| Intersection ID: 47835 | Main Street: CAMP_VERDE_LN | Cross Street: CACTUS_VALLEY_RD | Location: SW |

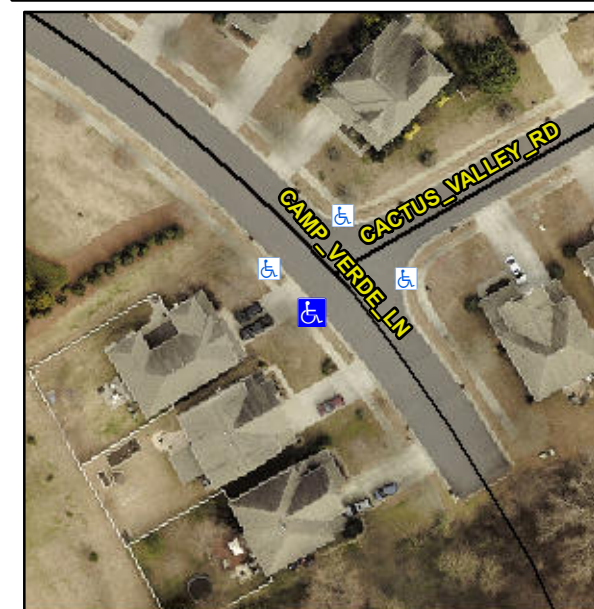
| ADA ID: F21EE7ED5647 | Ramp Type: Perp | Initial Pass/Fail: Fail | Overall Compliance: No |
| Severity Score: 8.75 | | | |

**Not Found, R304.5.1**

| Compliance | Description | Data | Compliance | Description | Data |
|---|---|---|---|---|---|
| No | Ramp Width (in) | 47.0 | Yes | Ramp XSlope (%) | 1.3 |

**Remove & Replace Entire Ramp.**

Total Cost: \$ 1850.00

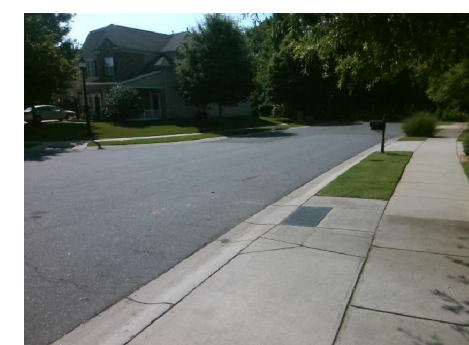
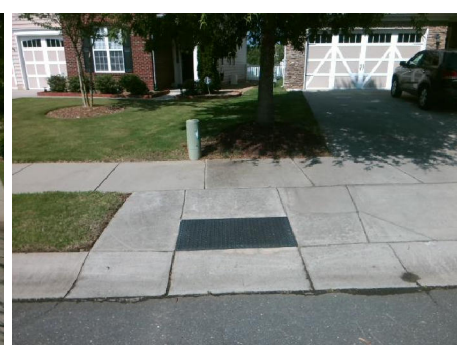
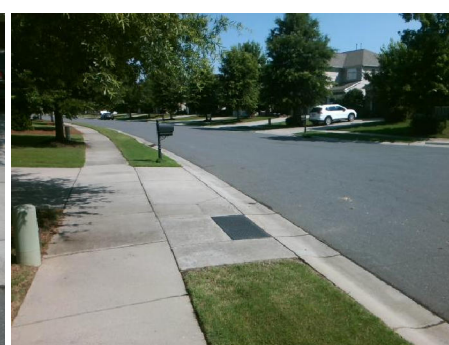
| Compliance | Description | Data | Compliance | Description | Data |
|---|---|---|---|---|---|
| N/A | Ramp Length (in) | 69.0 | Yes | Ramp Slope (%) | 7.9 |
