Access Compliance Report

Public Rights-of-Way (Curb Ramps)

Intersection ID: 7106	Main Street: GRAHAM_MEADOW_DR	Cross Street: LOVE_RIDGE_LN	Location:	S
ADA ID: F2213D83E76D	Ramp Type: Directional1	Initial Pass/Fail: Fail	Overall Compliance: No	Severity Score: 25
Codes/Mitigation Info/Possible Solution		Field Measurements/Component Compliance

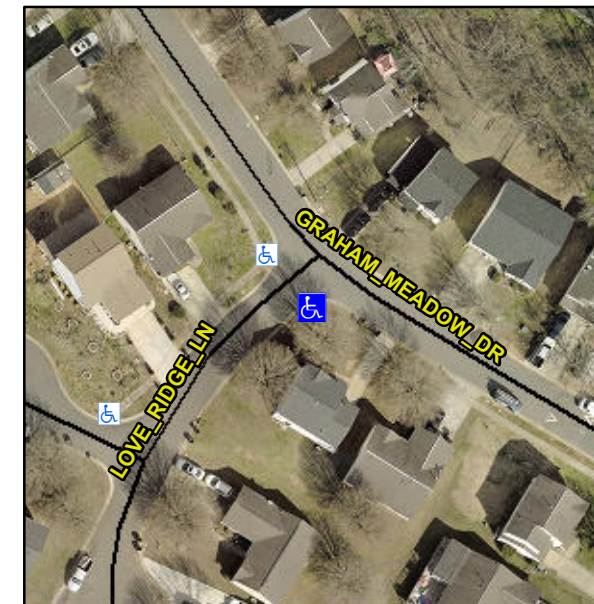
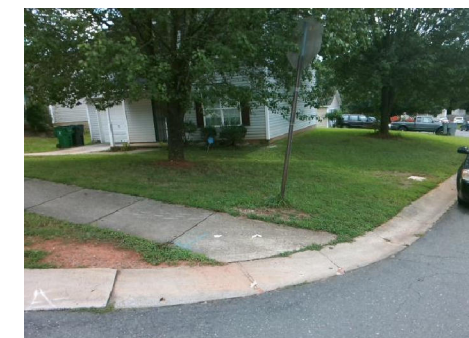
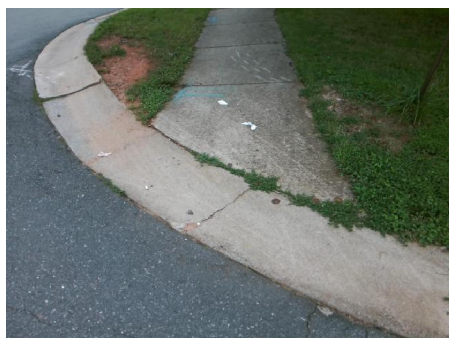
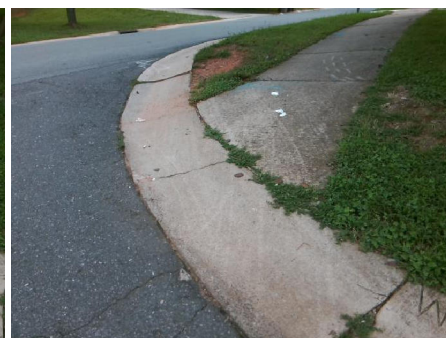
Compliance	Description	Data	Compliance	Description	Data
N/A	Ramp Length (in)	32.0	N/A	Grade Break?	N/A
Yes	Ramp Width (in)	52.0	N/A	Grade Break Slope (%)	0.0
No	Ramp Slope (%)	15.4	N/A	Grade Break XSlope (%)	0.0
Yes	Ramp XSlope (%)	0.7			
N/A	Flare Type LT	N/A	N/A	Flare Type RT	N/A
N/A	Flare Slope LT (%)	N/A	N/A	Flare Slope RT (%)	0.0
N/A	Flare Traversable LT?	N/A	N/A	Flare Traversable RT?	N/A
N/A	Landing Length (in)	0.0	N/A	DWS Provided?	N/A
N/A	Landing Width (in)	0.0	N/A	DWS Contrast?	N/A
N/A	Landing Slope (%)	0.0	N/A	DWS Length (in)	N/A
N/A	Landing X Slope (%)	0.0	N/A	DWS Full Width?	N/A
N/A	Landing Curb? (Y/N)	N/A	N/A	DWS Offset LT (in)	N/A
N/A	Shared Landing?	N/A	N/A	DWS Offset RT (in)	N/A
N/A	Gutter Ponding?	0.0	N/A	Gutter Slope (%)	N/A
N/A	Gutter Lip Ht (in)	0.5	N/A	Gutter X Slope (%)	N/A
N/A	Painted X Walk1?	No		Road Slope (%)	0.3
	X Walk 1 Direction	To NW		Road X Slope (%)	6.1
	X Walk 1 Width (in)	N/A		Clear Space?	N/A

X Walk 1 Slope (%)	0.3	N/A	Clear Space to XWalk (in)	N/A
	X Walk 1 X Slope (%)	6.1	N/A	Storm Grate/Utility Hazard?	N/A
N/A	Ramp inside XWalk1?	N/A		Storm Grate/Utility Type	
N/A	Any Obstructions?	N/A			N/A
	Obstruction Type		Yes	Surface Condition? (G/P)	Good
			N/A	Curb Slope (%)	23.8

Remove & Replace Entire Ramp.

R304.2.2
