# Access Compliance Report

## Public Rights-of-Way (Curb Ramps)

Intersection ID: 42945	Main Street: MOONDANCE_LN	Cross Street: SONOMA_VALLEY_DR	Location: SW
ADA ID: F22C0F321B3B	Ramp Type: Perp	Initial Pass/Fail: Fail	Overall Compliance: No
		Severity Score: 22.5

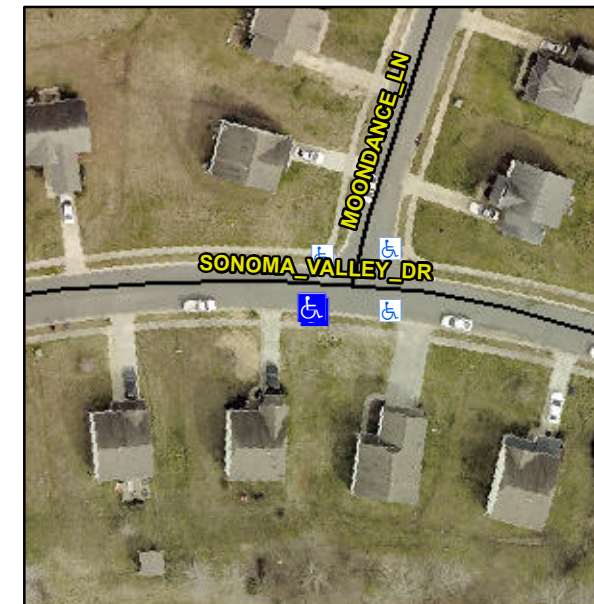
**Not Found, R304.5.1, R304.2.2, R304.5.3**

Compliance	Description	Data	Compliance	Description	Data
N/A	Ramp Length (in)	48.5	No	Ramp Slope (%)	8.4
No	Ramp Width (in)	44.0	No	Ramp XSlope (%)	2.4
N/A	Flare Type LT	N/A	N/A	Flare Type RT	N/A
N/A	Flare Slope LT (%)	N/A	N/A	Flare Slope RT (%)	N/A
N/A	Flare Traversable LT?	N/A	N/A	Flare Traversable RT?	N/A
N/A	Landing Length (in)	N/A	N/A	DWS Provided?	N/A
N/A	Landing Width (in)	N/A	N/A	DWS Contrast?	N/A
N/A	Landing Slope (%)	N/A	N/A	DWS Length (in)	N/A
N/A	Landing X Slope (%)	N/A	N/A	DWS Full Width?	N/A
N/A	Landing Curb? (Y/N)	N/A	N/A	DWS Offset (in)	N/A
N/A	Shared Landing?	N/A			
N/A	Gutter Ponding?	N/A	N/A	Gutter Slope (%)	N/A
N/A	Gutter Lip Ht (in)	N/A	N/A	Gutter X Slope (%)	N/A
N/A	Painted X Walk1?	No	N/A	Painted X Walk2?	N/A
	X Walk 1 Direction	To N		X Walk 2 Direction	N/A
N/A	X Walk 1 Width (in)	N/A	N/A	X Walk 2 Width (in)	N/A
	X Walk 1 Slope (%)	1.7		X Walk 2 Slope (%)	N/A
	X Walk 1 X Slope (%)	2.3		X Walk 2 X Slope (%)	N/A

N/A	Ramp inside XWalk1?	N/A	N/A	Ramp inside XWalk2?	N/A
	Road Slope (%)	N/A	N/A	Clear Space?	N/A
	Road X Slope (%)	N/A	N/A	Clear Space to XWalk (in)	N/A
N/A	Any Obstructions?	N/A	N/A	Storm Grate/Utility Hazard?	N/A
	Obstruction Type			Storm Grate/Utility Type	
		N/A			N/A
			Yes	Surface Condition? (G/P)	Good

**Remove & Replace Entire Ramp.**
