# Access Compliance Report

## Public Rights-of-Way

### (Curb Ramps)

| Intersection ID: 49295 | Main Street: CREEKSIDE_PARK_RD | Cross Street: ROYAL_WINCHESTER_DR | Location: N |

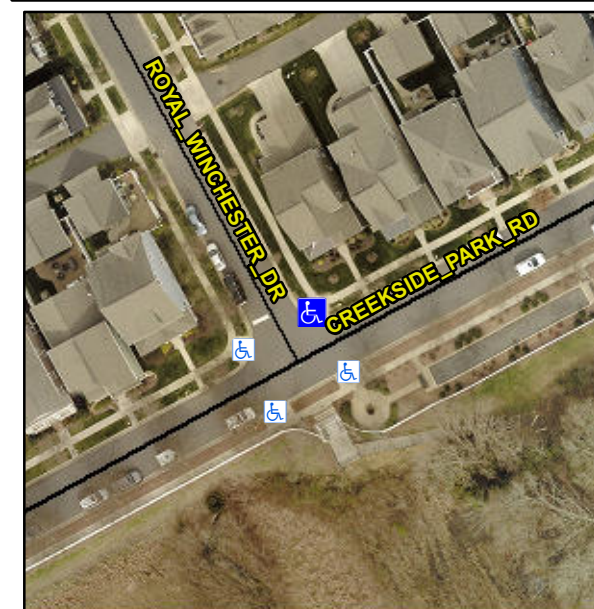
**CURB WIDTH 44.0**

**Not Found, R304.5.3, R304.2.1, R304.2.2-Perp, R304.3.2-Para, R305.2**

| Compliance | Description | Data | Compliance | Description | Data |
|---|---|---|---|---|---|
| Yes | Ramp Width (in) | 48.0 | No | BlendTrans XSlope (%) | 4.3 |
| No | Landing Length (in) | 43.0 | Yes | DWS Provided? | Yes |
| No | Landing Slope (%) | 3.3 | Yes | DWS Length (in) | 24.0 |
| No | Landing X Slope (%) | 5.0 | Yes | DWS Full Width? | Yes |
| N/A | Landing Curb? (Y/N) | No | No | DWS Offset (in) | 6.0 |
| Yes | Gutter Lip Ht (in) | 0.0 | No | Gutter X Slope (%) | 3.3 |
| | | | No | Curb Slope (%) | 21.6 |

**Remove & Replace Curb Ramp With Two New Directional Ramps or Equivalent. Remove & Replace Gutter.**
