# Access Compliance Report

## Public Rights-of-Way

### (Curb Ramps)

| Intersection ID: 14441 | Main Street: E_KINGSTON_AV | Cross Street: SPRINGDALE_AV | Location: S |

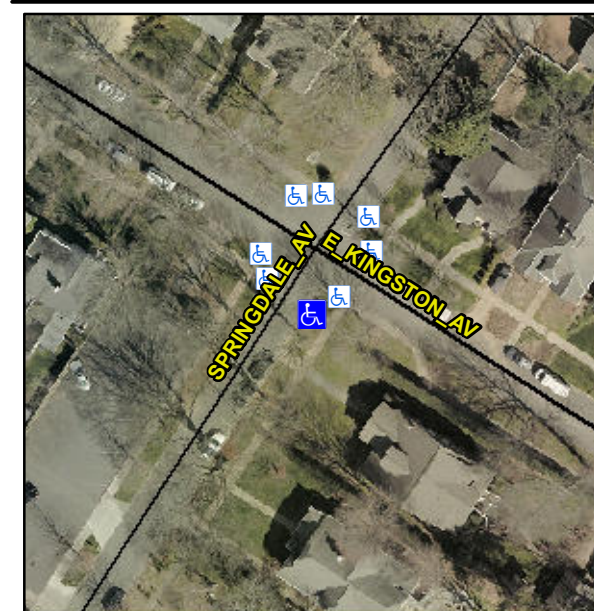
| ADA ID: F23EF98EF9EB | Ramp Type: Perp | Initial Pass/Fail: Fail | Overall Compliance: No |
| Severity Score: 12.5 | | | |

**Not Found, R304.2.2**

| Compliance | Description | Data | Compliance | Description | Data |
|---|---|---|---|---|---|
| N/A | Ramp Length (in) | 124.0 | No | Ramp Slope (%) | 8.6 |
| N/A | Gutter Ponding? | Yes | N/A | Gutter Slope (%) | N/A |
| N/A | Gutter Lip Ht (in) | 1.0 | N/A | Gutter X Slope (%) | N/A |

Possible Solutions:

**Remove & Replace Entire Ramp.**

Total Cost: \$ 1850.00
