Access Compliance Report

Public Rights-of-Way

(Curb Ramps)

Intersection ID: 52986	Main Street: GREYTHORNE DR	Cross Street: LANDING_PLACE_LN	Location: E
ADA ID: F2446F1216EA	Ramp Type: BlendTrans1	Initial Pass/Fail: Pass	Overall Compliance: No
Severity Score: 0			
Codes/Mitigation Info/Possible Solution		Field Measurements/Component Compliance

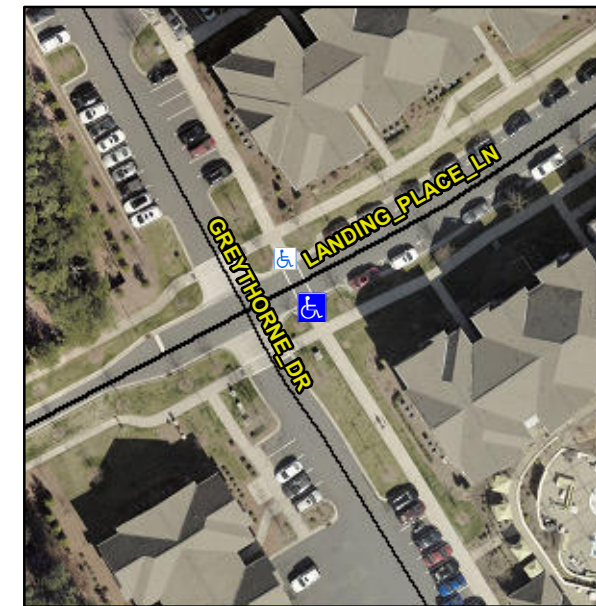
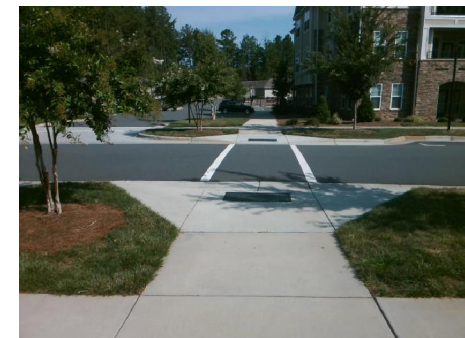
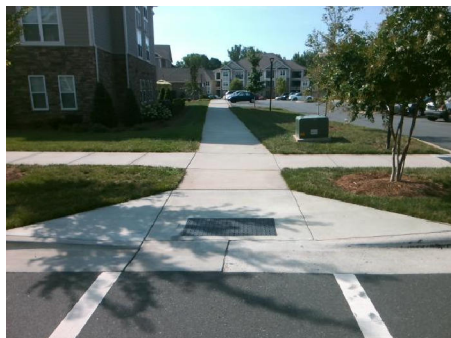
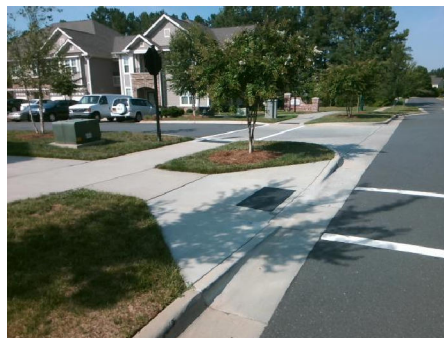
Compliance	Description	Data	Compliance	Description	Data
N/A	Ramp Length (in)	84.0	Yes	BlendTrans Slope (%)	1.3
Yes	Ramp Width (in)	84.0	Yes	BlendTrans XSlope (%)	1.0
N/A	Flare Type LT	Sloped	N/A	Flare Type RT	Sloped
N/A	Flare Slope LT (%)	3.3	N/A	Flare Slope RT (%)	7.7
N/A	Flare Traversable LT?	No	N/A	Flare Traversable RT?	No
Yes	Landing Length (in)	61.0	Yes	DWS Provided?	Yes
Yes	Landing Width (in)	84.0	Yes	DWS Contrast?	Yes
Yes	Landing Slope (%)	0.3	Yes	DWS Length (in)	24.0
Yes	Landing X Slope (%)	0.3	Yes	DWS Full Width?	Yes
N/A	Landing Curb? (Y/N)	No	No	DWS Offset (in)	4.0
N/A	Shared Landing?	No			
Yes	Gutter Ponding?	No	Yes	Gutter Slope (%)	3.3
Yes	Gutter Lip Ht (in)	0.0	Yes	Gutter X Slope (%)	1.8
N/A	Painted X Walk1?	Yes	N/A	Painted X Walk2?	N/A
	X Walk 1 Direction	To NW		X Walk 2 Direction	N/A
	X Walk 1 Width (in)	82.0		X Walk 2 Width (in)	N/A
	X Walk 1 Slope (%)	2.0		X Walk 2 Slope (%)	N/A
	X Walk 1 X Slope (%)	1.1		X Walk 2 X Slope (%)	N/A

Yes	Ramp inside XWalk1?	Yes	N/A	Ramp inside XWalk2?	N/A
	Road Slope (%)	1.1		Clear Space?	Yes
	Road X Slope (%)	2.0	N/A	Clear Space to XWalk (in)	N/A
Yes	Any Obstructions?	No	Yes	Storm Grate/Utility Hazard?	No
	Obstruction Type			Storm Grate/Utility Type	
		N/A			N/A
			Yes	Surface Condition? (G/P)	Good
			No	Curb Slope (%)	5.8

Remove & Replace Curb Ramp With Two New Directional Ramps or Equivalent.

Not Found, R305.2

Total Cost: \$ 3200.00
