Access Compliance Report

Public Rights-of-Way

(Curb Ramps)

Intersection ID: 26275	Main Street: PARK_RD	Cross Street: TRADEWINDS_LN	Location: NW
ADA ID: F24533EBDE3E	Ramp Type: PerpDiag	Initial Pass/Fail: Fail	Overall Compliance: No
Severity Score: 33.75			
Codes/Mitigation Info/Possible Solution		Field Measurements/Component Compliance

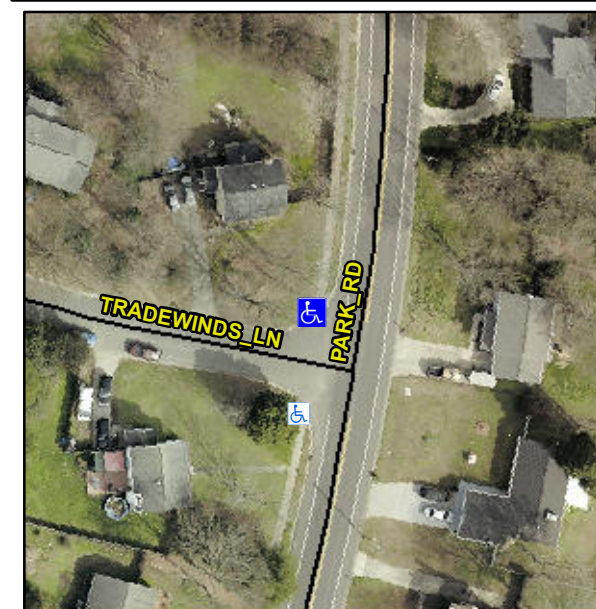
Not Found, R304.5.1, R304.5.3

Compliance	Description	Data	Compliance	Description	Data
N/A	Ramp Length (in)	68.0	Yes	Ramp Slope (%)	6.3
No	Ramp Width (in)	46.0	No	Ramp XSlope (%)	7.7
N/A	Flare Type LT	N/A	N/A	Flare Type RT	N/A
N/A	Flare Slope LT (%)	N/A	N/A	Flare Slope RT (%)	N/A
N/A	Flare Traversable LT?	N/A	N/A	Flare Traversable RT?	N/A
N/A	Landing Length (in)	N/A	N/A	DWS Provided?	N/A
N/A	Landing Width (in)	N/A	N/A	DWS Contrast?	N/A
N/A	Landing Slope (%)	N/A	N/A	DWS Length (in)	N/A
N/A	Landing X Slope (%)	N/A	N/A	DWS Full Width?	N/A
N/A	Landing Curb? (Y/N)	N/A	N/A	DWS Offset (in)	N/A
N/A	Shared Landing?	N/A			
N/A	Gutter Ponding?	N/A	N/A	Gutter Slope (%)	N/A
N/A	Gutter Lip Ht (in)	N/A	N/A	Gutter X Slope (%)	N/A
N/A	Painted X Walk1?	No	N/A	Painted X Walk2?	No
	X Walk 1 Direction	To S		X Walk 2 Direction	To E
N/A	X Walk 1 Width (in)	N/A	N/A	X Walk 2 Width (in)	N/A
	X Walk 1 Slope (%)	3.7		X Walk 2 Slope (%)	1.8
	X Walk 1 X Slope (%)	3.4		X Walk 2 X Slope (%)	2.8

N/A	Ramp inside XWalk1?	N/A	N/A	Ramp inside XWalk2?	N/A
	Road Slope (%)	5.8	N/A	Clear Space?	N/A
	Road X Slope (%)	1.0	N/A	Clear Space to XWalk (in)	N/A
N/A	Any Obstructions?	N/A	N/A	Storm Grate/Utility Hazard?	N/A
	Obstruction Type			Storm Grate/Utility Type	
		N/A			N/A
		Yes		Surface Condition? (G/P)	Good

Possible Solutions:

Remove & Replace Curb Ramp With Two New Directional Ramps or Equivalent.

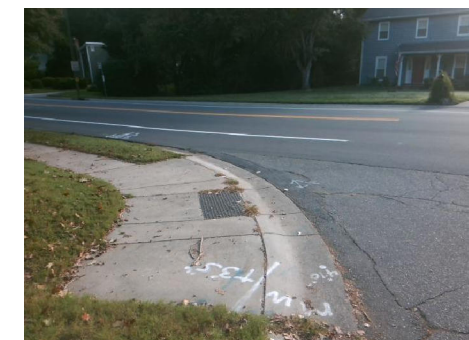
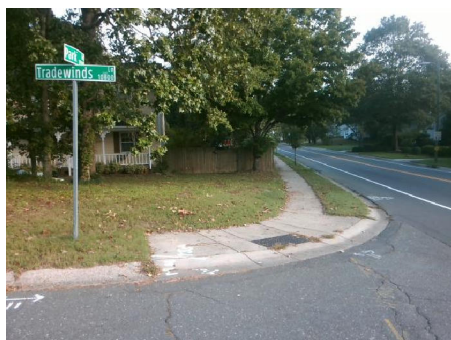
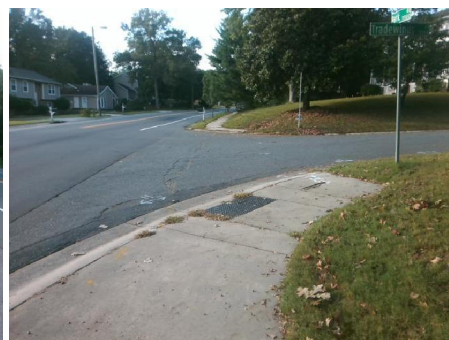
Street 1 Name TRADEWINDS LN
 Stop Condition-Street 2 StopSign
 Street 2 Name PARK RD
 Stop Condition-Street 1 None
