Access Compliance Report

Public Rights-of-Way

(Curb Ramps)

Intersection ID: 14880	Main Street: ALBEMARLE_RD	Cross Street: KINGHURST_DR	Location: NW
ADA ID: F260BEF59F97	Ramp Type: Perp	Initial Pass/Fail: Fail	Overall Compliance: No
Severity Score: 12.5			
Codes/Mitigation Info/Possible Solution		Field Measurements/Component Compliance

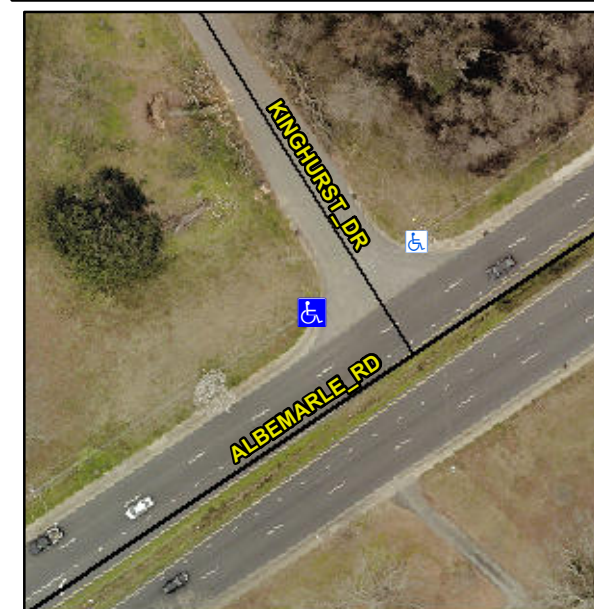
PROW/ADA:

Not Found, R304.2.2

Compliance	Description	Data	Compliance	Description	Data
N/A	Ramp Length (in)	60.5	No	Ramp Slope (%)	9.8
Yes	Ramp Width (in)	48.0	Yes	Ramp XSlope (%)	0.6
N/A	Flare Type LT	N/A	N/A	Flare Type RT	N/A
N/A	Flare Slope LT (%)	N/A	N/A	Flare Slope RT (%)	N/A
N/A	Flare Traversable LT?	N/A	N/A	Flare Traversable RT?	N/A
N/A	Landing Length (in)	N/A	N/A	DWS Provided?	N/A
N/A	Landing Width (in)	N/A	N/A	DWS Contrast?	N/A
N/A	Landing Slope (%)	N/A	N/A	DWS Length (in)	N/A
N/A	Landing X Slope (%)	N/A	N/A	DWS Full Width?	N/A
N/A	Landing Curb? (Y/N)	N/A	N/A	DWS Offset (in)	N/A
N/A	Shared Landing?	N/A			
N/A	Gutter Ponding?	N/A	N/A	Gutter Slope (%)	N/A
N/A	Gutter Lip Ht (in)	2.0	N/A	Gutter X Slope (%)	N/A
N/A	Painted X Walk1?	No	N/A	Painted X Walk2?	N/A
	X Walk 1 Direction	To NE		X Walk 2 Direction	N/A
N/A	X Walk 1 Width (in)	N/A	N/A	X Walk 2 Width (in)	N/A
	X Walk 1 Slope (%)	0.7		X Walk 2 Slope (%)	N/A
	X Walk 1 X Slope (%)	1.1		X Walk 2 X Slope (%)	N/A

N/A	Ramp inside XWalk1?	N/A	N/A	Ramp inside XWalk2?	N/A
	Road Slope (%)	N/A	N/A	Clear Space?	N/A
	Road X Slope (%)	N/A	N/A	Clear Space to XWalk (in)	N/A
N/A	Any Obstructions?	N/A	N/A	Storm Grate/Utility Hazard?	N/A
	Obstruction Type			Storm Grate/Utility Type	
		N/A			N/A
			Yes	Surface Condition? (G/P)	Good

Possible Solutions:

Remove & Replace Entire Ramp.

Total Cost: \$ 1850.00
