Access Compliance Report

Public Rights-of-Way

(Curb Ramps)

Intersection ID: 9781	Main Street: HARWYN_DR	Cross Street: THE_PLAZA	Location: SW
ADA ID: F263CB5CB3BB	Ramp Type: Perp	Initial Pass/Fail: Fail	Overall Compliance: No
Severity Score: 21.25			
Codes/Mitigation Info/Possible Solution		Field Measurements/Component Compliance

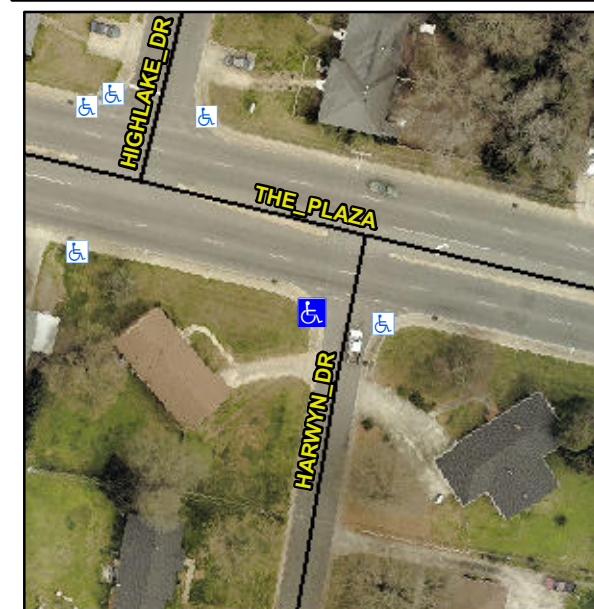
Not Found, R304.5.1, R304.2.2

Compliance	Description	Data	Compliance	Description	Data
N/A	Ramp Length (in)	58.0	No	Ramp Slope (%)	8.8
No	Ramp Width (in)	47.5	Yes	Ramp XSlope (%)	0.3
N/A	Flare Type LT	N/A	N/A	Flare Type RT	N/A
N/A	Flare Slope LT (%)	N/A	N/A	Flare Slope RT (%)	N/A
N/A	Flare Traversable LT?	N/A	N/A	Flare Traversable RT?	N/A
N/A	Landing Length (in)	N/A	N/A	DWS Provided?	N/A
N/A	Landing Width (in)	N/A	N/A	DWS Contrast?	N/A
N/A	Landing Slope (%)	N/A	N/A	DWS Length (in)	N/A
N/A	Landing X Slope (%)	N/A	N/A	DWS Full Width?	N/A
N/A	Landing Curb? (Y/N)	N/A	N/A	DWS Offset (in)	N/A
N/A	Shared Landing?	N/A			
N/A	Gutter Ponding?	N/A	N/A	Gutter Slope (%)	N/A
N/A	Gutter Lip Ht (in)	N/A	N/A	Gutter X Slope (%)	N/A
N/A	Painted X Walk1?	No	N/A	Painted X Walk2?	N/A
	X Walk 1 Direction	To SE		X Walk 2 Direction	N/A
N/A	X Walk 1 Width (in)	N/A	N/A	X Walk 2 Width (in)	N/A
	X Walk 1 Slope (%)	1.3		X Walk 2 Slope (%)	N/A
	X Walk 1 X Slope (%)	2.9		X Walk 2 X Slope (%)	N/A

N/A	Ramp inside XWalk1?	N/A	N/A	Ramp inside XWalk2?	N/A
	Road Slope (%)	N/A	N/A	Clear Space?	N/A
	Road X Slope (%)	N/A	N/A	Clear Space to XWalk (in)	N/A
N/A	Any Obstructions?	N/A	N/A	Storm Grate/Utility Hazard?	N/A
	Obstruction Type			Storm Grate/Utility Type	
		N/A			N/A
			Yes	Surface Condition? (G/P)	Good

Possible Solutions:

Remove & Replace Entire Ramp.
