Access Compliance Report

Public Rights-of-Way

(Curb Ramps)

Intersection ID: 54217	Main Street: GOLF_LINKS_DR	Cross Street: MIDWAY_PARK_DR	Location: SW
ADA ID: F26C445B4A51	Ramp Type: Perp	Initial Pass/Fail: Fail	Overall Compliance: No
Severity Score: 12.5			
Codes/Mitigation Info/Possible Solution		Field Measurements/Component Compliance

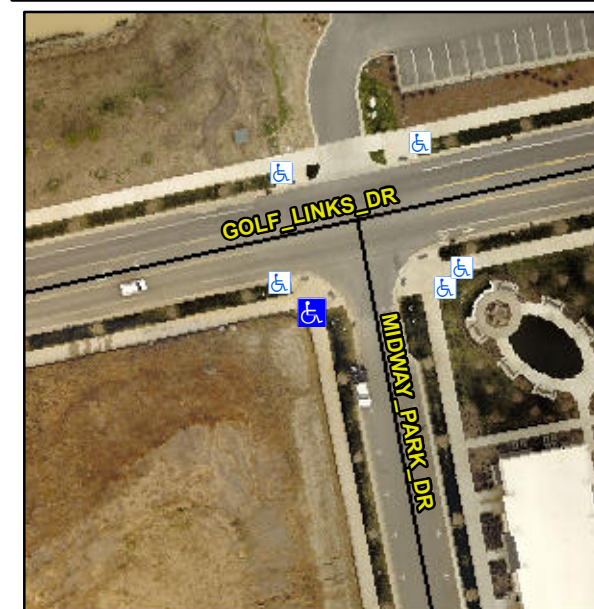
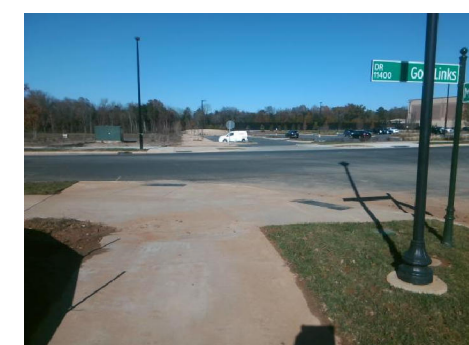
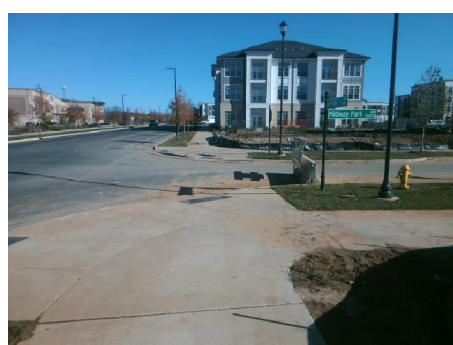
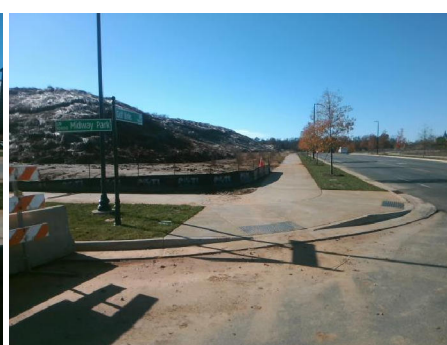
Not Found, R304.2.2

Compliance	Description	Data	Compliance	Description	Data
N/A	Ramp Length (in)	105.0	No	Ramp Slope (%)	8.7
Yes	Ramp Width (in)	52.0	Yes	Ramp XSlope (%)	1.1
N/A	Flare Type LT	N/A	N/A	Flare Type RT	N/A
N/A	Flare Slope LT (%)	N/A	N/A	Flare Slope RT (%)	N/A
N/A	Flare Traversable LT?	N/A	N/A	Flare Traversable RT?	N/A
N/A	Landing Length (in)	N/A	N/A	DWS Provided?	N/A
N/A	Landing Width (in)	N/A	N/A	DWS Contrast?	N/A
N/A	Landing Slope (%)	N/A	N/A	DWS Length (in)	N/A
N/A	Landing X Slope (%)	N/A	N/A	DWS Full Width?	N/A
N/A	Landing Curb? (Y/N)	N/A	N/A	DWS Offset (in)	N/A
N/A	Shared Landing?	N/A			
N/A	Gutter Ponding?	N/A	N/A	Gutter Slope (%)	N/A
N/A	Gutter Lip Ht (in)	N/A	N/A	Gutter X Slope (%)	N/A
N/A	Painted X Walk1?	No	N/A	Painted X Walk2?	N/A
	X Walk 1 Direction	To E		X Walk 2 Direction	N/A
N/A	X Walk 1 Width (in)	N/A	N/A	X Walk 2 Width (in)	N/A
	X Walk 1 Slope (%)	1.9		X Walk 2 Slope (%)	N/A
	X Walk 1 X Slope (%)	2.8		X Walk 2 X Slope (%)	N/A

Remove & Replace Entire Ramp.
