## Access Compliance Report Public Rights-of-Way (Curb Ramps)

Intersection ID: 31710 Main Street: ALDER\_CT Cross Street: PLOWDON\_CT Location: S

ADA ID: F26CC182975E Ramp Type: PerpDiag Initial Pass/Fail: Fail Overall Compliance: No Severity Score: 33.75

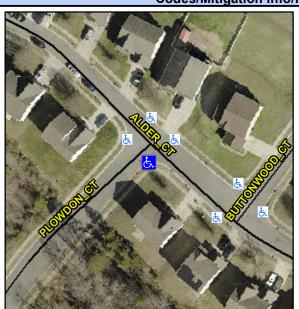
Tiola measuremente/compensate							
	Compliance Description		Data	Compliance		Description	Data
	N/A	Ramp Length (in)	49.0	Yes	Ramp	Slope (%)	6.3
	No	Ramp Width (in)	47.5	No	Ramp	XSlope (%)	9.1
	N/A	Flare Type LT	N/A	N/A	Flare	Type RT	N/A
	N/A	Flare Slope LT (%)	N/A	N/A	Flare	Slope RT (%)	N/A
	N/A	Flare Traversable LT?	N/A	N/A	Flare	Traversable RT?	N/A
	N/A	Landing Length (in)	N/A	N/A	DWS	Provided?	N/A
	N/A	Landing Width (in)	N/A	N/A	DWS	Contrast?	N/A
	N/A	Landing Slope (%)	N/A	N/A	DWS	Length (in)	N/A
	N/A	Landing X Slope (%)	N/A	N/A	DWS	Full Width?	N/A
	N/A	Landing Curb? (Y/N)	N/A	N/A	DWS	Offset (in)	N/A
	N/A	Shared Landing?	N/A				
	N/A	Gutter Ponding?	N/A	N/A	Gutte	r Slope (%)	N/A
	N/A	Gutter Lip Ht (in)	N/A	N/A	Gutte	r X Slope (%)	N/A
	N/A	Painted X Walk1?	No	N/A	Painte	ed X Walk2?	No
		X Walk 1 Direction	To NE		X Wal	lk 2 Direction	To NW
	N/A	X Walk 1 Width (in)	N/A	N/A	X Wal	lk 2 Width (in)	N/A
		X Walk 1 Slope (%)	6.8		X Wal	lk 2 Slope (%)	0.7

X Walk 1 X Slope (%)	3.1		X Wal	lk 2 X Slope (%)	4.0
	N/A	Ramp inside XWalk1?	N/A	N/A	Ramp	inside XWalk2?	N/A
		Road Slope (%)	6.0	N/A	Clear	Space?	N/A
		Road X Slope (%)	0.2	N/A	Clear	Space to XWalk (in)	N/A

Remove & Replace Curb Ramp With Two New Directional Ramps or Equivalent.

R304.5.1, R304.5.3
