Access Compliance Report

Public Rights-of-Way

(Curb Ramps)

Intersection ID: 13709	Main Street: SHENANDOAH_AV	Cross Street: ST_JULIEN_ST	Location:	N
ADA ID: F270FB062A06	Ramp Type: PerpDiag	Initial Pass/Fail: Fail	Overall Compliance: No	Severity Score: 22.5

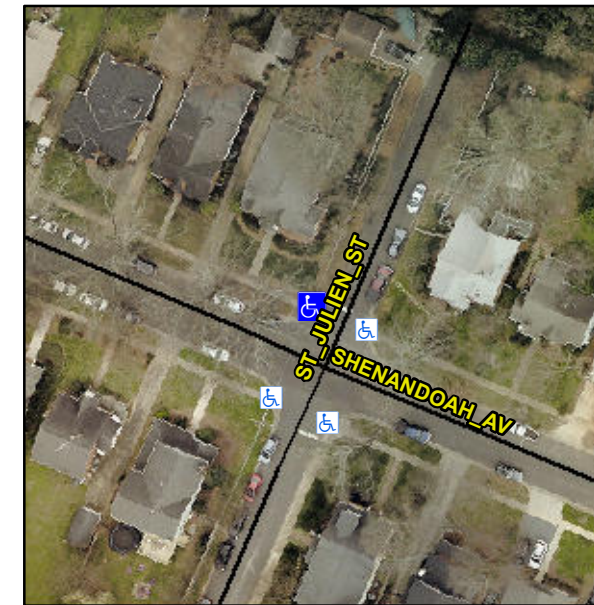
Not Found, R304.5.1, R304.2.2, R304.5.3

Compliance	Description	Data	Compliance	Description	Data
N/A	Ramp Length (in)	38.0	No	Ramp Slope (%)	8.4
No	Ramp Width (in)	47.5	No	Ramp XSlope (%)	3.5
N/A	Flare Type LT	N/A	N/A	Flare Type RT	N/A
N/A	Flare Slope LT (%)	N/A	N/A	Flare Slope RT (%)	N/A
N/A	Flare Traversable LT?	N/A	N/A	Flare Traversable RT?	N/A
N/A	Landing Length (in)	N/A	N/A	DWS Provided?	N/A
N/A	Landing Width (in)	N/A	N/A	DWS Contrast?	N/A
N/A	Landing Slope (%)	N/A	N/A	DWS Length (in)	N/A
N/A	Landing X Slope (%)	N/A	N/A	DWS Full Width?	N/A
N/A	Landing Curb? (Y/N)	N/A	N/A	DWS Offset (in)	N/A
N/A	Shared Landing?	N/A			
N/A	Gutter Ponding?	N/A	N/A	Gutter Slope (%)	N/A
N/A	Gutter Lip Ht (in)	N/A	N/A	Gutter X Slope (%)	N/A
N/A	Painted X Walk1?	No	N/A	Painted X Walk2?	No
	X Walk 1 Direction	To SW		X Walk 2 Direction	To SE
N/A	X Walk 1 Width (in)	N/A	N/A	X Walk 2 Width (in)	N/A
	X Walk 1 Slope (%)	1.6		X Walk 2 Slope (%)	3.5
	X Walk 1 X Slope (%)	1.8		X Walk 2 X Slope (%)	1.3

N/A	Ramp inside XWalk1?	N/A	N/A	Ramp inside XWalk2?	N/A
	Road Slope (%)	2.4	N/A	Clear Space?	N/A
	Road X Slope (%)	3.1	N/A	Clear Space to XWalk (in)	N/A
N/A	Any Obstructions?	N/A	N/A	Storm Grate/Utility Hazard?	N/A
	Obstruction Type			Storm Grate/Utility Type	
		N/A			N/A
			Yes	Surface Condition? (G/P)	Good

Remove & Replace Curb Ramp With Two New Directional Ramps or Equivalent.
