Intersection ID: 52246	Main Street: CENTERLINE_DR	Cross Street: KNOX_FARM_RD	Location:	NE
ADA ID: F272A9481E50	Ramp Type: PerpDiag	Initial Pass/Fail: Fail	Overall Compliance: No	Severity Score: 33.75

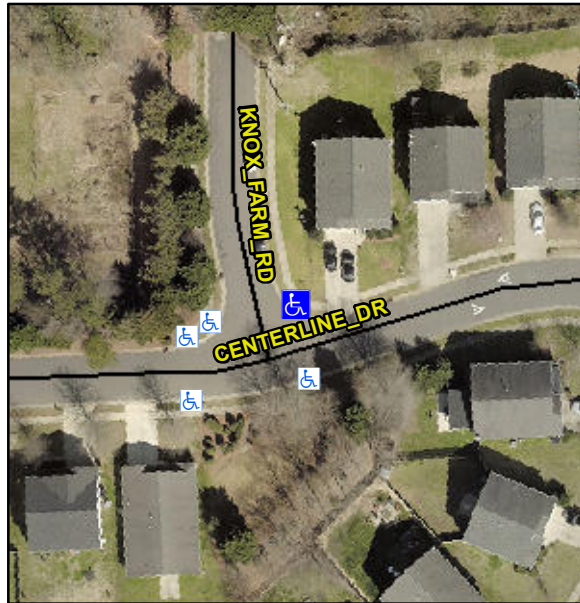
Compliance	Description	Data	Compliance	Description	Data
N/A	Ramp Length (in)	48.0	Yes	Ramp Slope (%)	7.4
No	Ramp Width (in)	37.0	No	Ramp XSlope (%)	8.0
N/A	Flare Type LT	N/A	N/A	Flare Type RT	N/A
N/A	Flare Slope LT (%)	N/A	N/A	Flare Slope RT (%)	N/A
N/A	Flare Traversable LT?	N/A	N/A	Flare Traversable RT?	N/A
N/A	Landing Length (in)	N/A	N/A	DWS Provided?	N/A
N/A	Landing Width (in)	N/A	N/A	DWS Contrast?	N/A
N/A	Landing Slope (%)	N/A	N/A	DWS Length (in)	N/A
N/A	Landing X Slope (%)	N/A	N/A	DWS Full Width?	N/A
N/A	Landing Curb? (Y/N)	N/A	N/A	DWS Offset (in)	N/A
N/A	Shared Landing?	N/A			
N/A	Gutter Ponding?	N/A	N/A	Gutter Slope (%)	N/A
N/A	Gutter Lip Ht (in)	N/A	N/A	Gutter X Slope (%)	N/A
N/A	Painted X Walk1?	No	N/A	Painted X Walk2?	No
	X Walk 1 Direction	To W		X Walk 2 Direction	To S
N/A	X Walk 1 Width (in)	N/A	N/A	X Walk 2 Width (in)	N/A
	X Walk 1 Slope (%)	4.9		X Walk 2 Slope (%)	1.0
	X Walk 1 X Slope (%)	1.2		X Walk 2 X Slope (%)	3.8

N/A	Ramp inside XWalk1?	N/A	N/A	Ramp inside XWalk2?	N/A
	Road Slope (%)	3.6	N/A	Clear Space?	N/A
	Road X Slope (%)	4.2	N/A	Clear Space to XWalk (in)	N/A
N/A	Any Obstructions?	N/A	N/A	Storm Grate/Utility Hazard?	N/A
	Obstruction Type			Storm Grate/Utility Type	
		N/A			N/A
			Yes	Surface Condition? (G/P)	Good

Remove & Replace Curb Ramp With Two New Directional Ramps or Equivalent.
