Access Compliance Report Public Rights-of-Way (Curb Ramps)

Intersection ID: 10026308 Main Street: FAIRVIEW RD Cross Street: N/A Location: NW Initial Pass/Fail: Fail **Overall Compliance: No Severity Score:** ADA ID: F2783D76A30F Ramp Type: PerpDiag 12.5

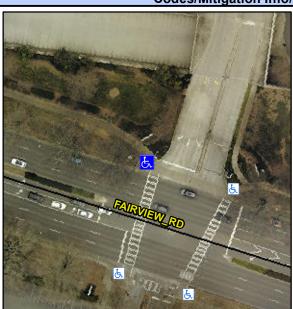
FAIRVIEW RD Street 1 Name Stop Condition-Street 2 Signal **ENTRANCE** Street 2 Name Stop Condition-Street 1 Signal Possible Solutions: Remove & Replace Curb Ramp With Two New Directional Ramps or Equivalent. Surveyor Notes: N/A PROW/ADA: R304.5.3
