Access Compliance Report

Public Rights-of-Way

(Curb Ramps)

Intersection ID: 11287	Main Street: CATAWBA_AV	Cross Street: UMSTEAD_ST	Location: SE
ADA ID: F27DF9A08458	Ramp Type: Perp	Initial Pass/Fail: Fail	Overall Compliance: No
		Severity Score: 25

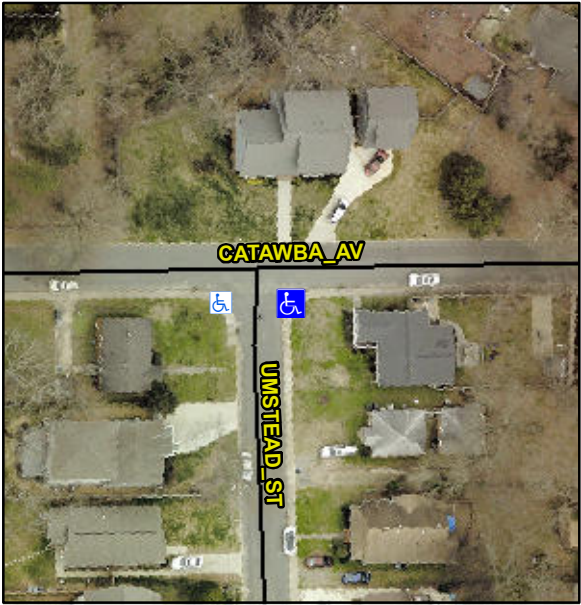
Possible Solutions:		Compliance	Description	Data
	Remove & Replace Entire Ramp.		No	Ramp Length (in)	53.5
			Yes	Ramp Width (in)	48.0
			N/A	Flare Type LT	N/A
			N/A	Flare Slope LT (%)	N/A
			N/A	Flare Traversable LT?	N/A
			N/A	Landing Length (in)	N/A
			N/A	Landing Width (in)	N/A
			N/A	Landing Slope (%)	N/A
			N/A	Landing X Slope (%)	N/A
<p>Surveyor Notes:</p> <p>N/A</p> <p>PROW/ADA:</p> <p>R304.2.2</p>			N/A	Flare Type RT	N/A
			N/A	Flare Slope RT (%)	N/A
			N/A	Flare Traversable RT?	N/A
			N/A	DWS Provided?	N/A
			N/A	DWS Contrast?	N/A
			N/A	DWS Length (in)	N/A
			N/A	DWS Full Width?	N/A
			N/A	DWS Offset (in)	N/A
			N/A	Shared Landing?	N/A
			N/A	Gutter Ponding?	N/A
			N/A	Gutter Lip Ht (in)	0.5
			N/A	Painted X Walk1?	No
				X Walk 1 Direction	To W
			N/A	X Walk 1 Width (in)	N/A
				X Walk 1 Slope (%)	2.4
				X Walk 1 X Slope (%)	1.8

N/A	Ramp inside XWalk1?	N/A
			N/A	Road Slope (%)	N/A
			N/A	Road X Slope (%)	N/A
			N/A	Any Obstructions?	N/A
Total Cost:		\$ 1850.00		Obstruction Type	
			N/A	Clear Space?	N/A
			N/A	Clear Space to XWalk (in)	N/A
			N/A	Storm Grate/Utility Hazard?	N/A
				Storm Grate/Utility Type	
			N/A		N/A
			Yes	Surface Condition? (G/P)	Good
