Access Compliance Report Public Rights-of-Way (Curb Ramps)

Intersection ID: 21239 Main Street: CAMBRIDGE BELTWAY DR **Cross Street: S TRYON ST** Location: NW

ADA ID: F285CAA93284 Ramp Type: PerpDiag Initial Pass/Fail: Fail **Overall Compliance: No** Severity Score: 36.25

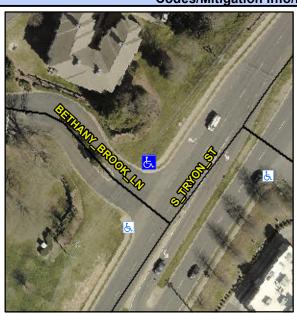
Data		oliance Description	Data	
N/A	Ramp Length (in)	93.0	Yes	Ramp Slope (%)	5.5	
No	Ramp Width (in)	31.0	No	Ramp XSlope (%)	3.3	
N/A	Flare Type LT	N/A	N/A	Flare Type RT	N/A	
N/A	Flare Slope LT (%)	N/A	N/A	Flare Slope RT (%)	N/A	
N/A	Flare Traversable LT?	N/A	N/A	Flare Traversable RT?	N/A	
N/A	Landing Length (in)	N/A	N/A	DWS Provided?	N/A	
N/A	Landing Width (in)	N/A	N/A	DWS Contrast?	N/A	
N/A	Landing Slope (%)	N/A	N/A	DWS Length (in)	N/A	
N/A	Landing X Slope (%)	N/A	N/A	DWS Full Width?	N/A	
N/A	Landing Curb? (Y/N)	N/A	N/A	DWS Offset (in)	N/A	
N/A	Shared Landing?	N/A				
N/A	Gutter Ponding?	N/A	N/A	Gutter Slope (%)	N/A	
N/A	Gutter Lip Ht (in)	N/A	N/A	Gutter X Slope (%)	N/A	
N/A	Painted X Walk1?	No	N/A	Painted X Walk2?	No	
	X Walk 1 Direction	To SW		X Walk 2 Direction	To SE	
N/A	X Walk 1 Width (in)	N/A	N/A	X Walk 2 Width (in)	N/A	
	X Walk 1 Slope (%)	3.5		X Walk 2 Slope (%)	1.5	
	X Walk 1 X Slope (%)	0.5		X Walk 2 X Slope (%)	2.3

N/A	Ramp inside XWalk1?	N/A	N/A	Ramp inside XWalk2?	N/A	
	Road Slope (%)	2.4	N/A	Clear Space?	N/A	
	Road X Slope (%)	0.7	N/A	Clear Space to XWalk (in)	N/A	
N/A	Any Obstructions?	N/A	N/A	Storm Grate/Utility Hazard?	N/A	
	Obstruction Type			Storm Grate/Utility Type		
		N/A			N/A	
			Yes	Surface Condition? (G/P)	Good

Remove & Replace Curb Ramp With Two New Directional Ramps or Equivalent.

Total Cost: 3200.00
