Access Compliance Report

Public Rights-of-Way

(Curb Ramps)

Intersection ID: 11659	Main Street: E_16TH_ST	Cross Street: N_DAVIDSON_ST	Location: W
ADA ID: F28944866A40	Ramp Type: PerpDiag	Initial Pass/Fail: Fail	Overall Compliance: No
		Severity Score: 22.5	
Codes/Mitigation Info/Possible Solution		Field Measurements/Component Compliance

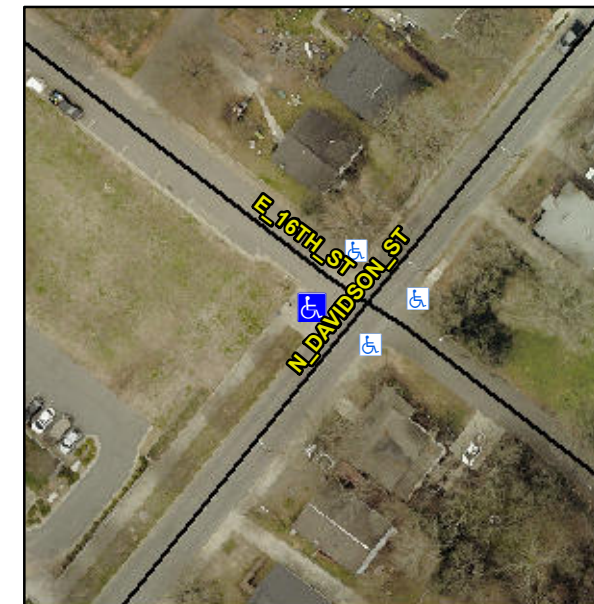
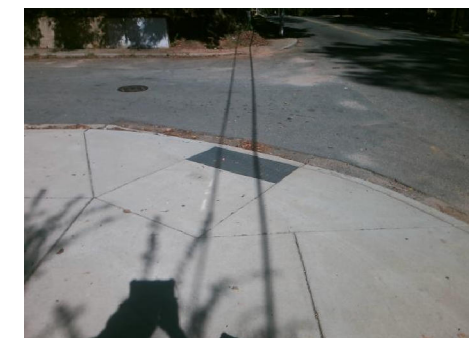
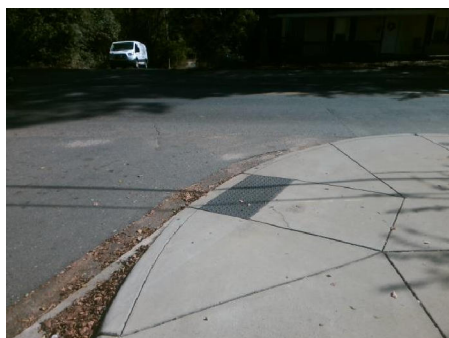
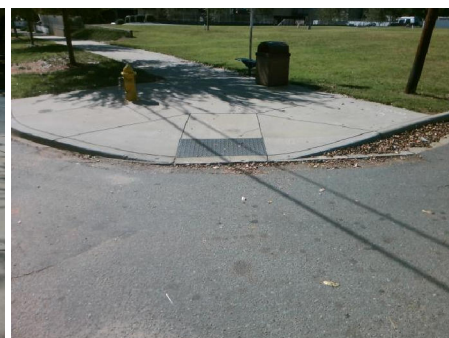
Not Found, R304.5.1, R304.2.2, R304.5.3

Compliance	Description	Data	Compliance	Description	Data
N/A	Ramp Length (in)	72.0	No	Ramp Slope (%)	9.3
No	Ramp Width (in)	47.5	No	Ramp XSlope (%)	2.8
N/A	Flare Type LT	N/A	N/A	Flare Type RT	N/A
N/A	Flare Slope LT (%)	N/A	N/A	Flare Slope RT (%)	N/A
N/A	Flare Traversable LT?	N/A	N/A	Flare Traversable RT?	N/A
N/A	Landing Length (in)	N/A	N/A	DWS Provided?	N/A
N/A	Landing Width (in)	N/A	N/A	DWS Contrast?	N/A
N/A	Landing Slope (%)	N/A	N/A	DWS Length (in)	N/A
N/A	Landing X Slope (%)	N/A	N/A	DWS Full Width?	N/A
N/A	Landing Curb? (Y/N)	N/A	N/A	DWS Offset (in)	N/A
N/A	Shared Landing?	N/A			
N/A	Gutter Ponding?	N/A	N/A	Gutter Slope (%)	N/A
N/A	Gutter Lip Ht (in)	1.5	N/A	Gutter X Slope (%)	N/A
N/A	Painted X Walk1?	No	N/A	Painted X Walk2?	No
	X Walk 1 Direction	To SE		X Walk 2 Direction	To NE
N/A	X Walk 1 Width (in)	N/A	N/A	X Walk 2 Width (in)	N/A
	X Walk 1 Slope (%)	1.3		X Walk 2 Slope (%)	2.7
	X Walk 1 X Slope (%)	1.6		X Walk 2 X Slope (%)	1.1

N/A	Ramp inside XWalk1?	N/A	N/A	Ramp inside XWalk2?	N/A
	Road Slope (%)	2.6	N/A	Clear Space?	N/A
	Road X Slope (%)	3.2	N/A	Clear Space to XWalk (in)	N/A
N/A	Any Obstructions?	N/A	N/A	Storm Grate/Utility Hazard?	N/A
	Obstruction Type			Storm Grate/Utility Type	
		N/A			N/A
			Yes	Surface Condition? (G/P)	Good

Remove & Replace Curb Ramp With Two New Directional Ramps or Equivalent.

Total Cost: \$ 3200.00
