Access Compliance Report

Public Rights-of-Way

(Curb Ramps)

Intersection ID: 45522	Main Street: LANSFORD_RD	Cross Street: WILBURN_CT	Location: E
ADA ID: F28A0281DD2D	Ramp Type: PerpDiag	Initial Pass/Fail: Fail	Overall Compliance: No
Severity Score: 13.75			
Codes/Mitigation Info/Possible Solution		Field Measurements/Component Compliance

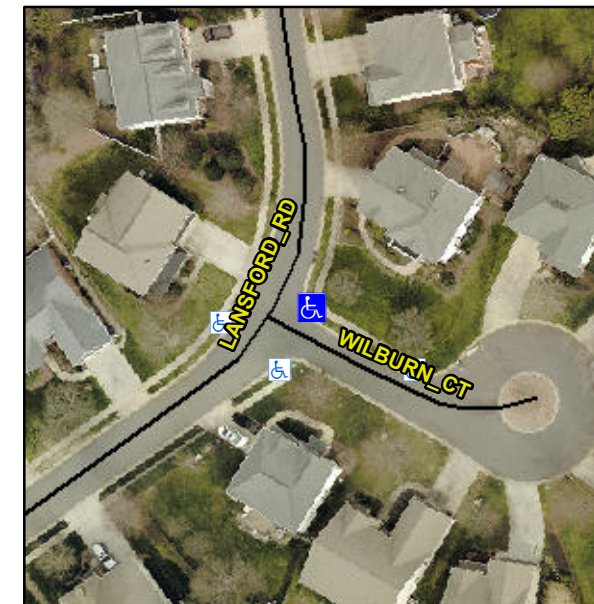
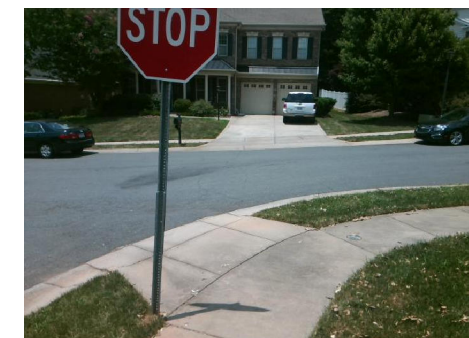
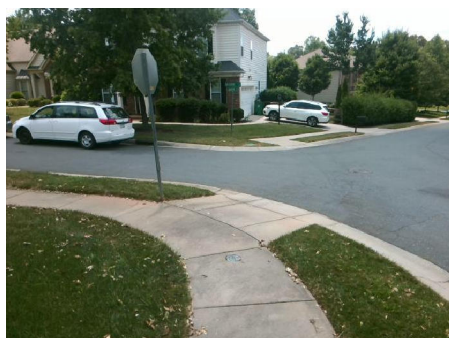
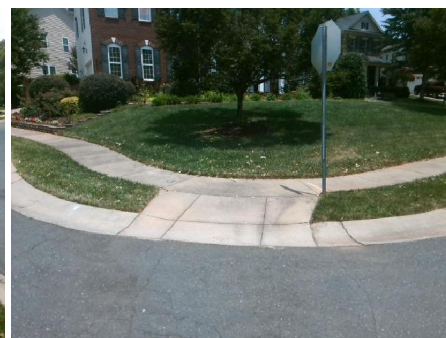
Compliance	Description	Data	Compliance	Description	Data
N/A	Ramp Length (in)	45.0	No	Ramp Slope (%)	8.7
Yes	Ramp Width (in)	48.0	No	Ramp XSlope (%)	3.8
N/A	Flare Type LT	N/A	N/A	Flare Type RT	N/A
N/A	Flare Slope LT (%)	N/A	N/A	Flare Slope RT (%)	N/A
N/A	Flare Traversable LT?	N/A	N/A	Flare Traversable RT?	N/A
N/A	Landing Length (in)	N/A	N/A	DWS Provided?	N/A
N/A	Landing Width (in)	N/A	N/A	DWS Contrast?	N/A
N/A	Landing Slope (%)	N/A	N/A	DWS Length (in)	N/A
N/A	Landing X Slope (%)	N/A	N/A	DWS Full Width?	N/A
N/A	Landing Curb? (Y/N)	N/A	N/A	DWS Offset (in)	N/A
N/A	Shared Landing?	N/A			
N/A	Gutter Ponding?	N/A	N/A	Gutter Slope (%)	N/A
N/A	Gutter Lip Ht (in)	N/A	N/A	Gutter X Slope (%)	N/A
N/A	Painted X Walk1?	No	N/A	Painted X Walk2?	No
	X Walk 1 Direction	To NW		X Walk 2 Direction	To SW
N/A	X Walk 1 Width (in)	N/A	N/A	X Walk 2 Width (in)	N/A
	X Walk 1 Slope (%)	1.2		X Walk 2 Slope (%)	3.9
	X Walk 1 X Slope (%)	3.6		X Walk 2 X Slope (%)	3.2

N/A	Ramp inside XWalk1?	N/A	N/A	Ramp inside XWalk2?	N/A
	Road Slope (%)	3.2	N/A	Clear Space?	N/A
	Road X Slope (%)	3.0	N/A	Clear Space to XWalk (in)	N/A
N/A	Any Obstructions?	N/A	N/A	Storm Grate/Utility Hazard?	N/A
	Obstruction Type			Storm Grate/Utility Type	
		N/A			N/A
		Yes		Surface Condition? (G/P)	Good

Possible Solutions:

Remove & Replace Curb Ramp With Two New Directional Ramps or Equivalent.

Not Found, R304.2.2, R304.5.3
