## **Access Compliance Report Public Rights-of-Way** (Curb Ramps)

Intersection ID: 42469 Main Street: KINGSLEY VIEW DR Cross Street: CASTLE\_WATCH\_AV Location: NE ADA ID: F28D62AA4930 Ramp Type: PerpDiag Initial Pass/Fail: Fail **Overall Compliance: No** Severity Score: 21.25

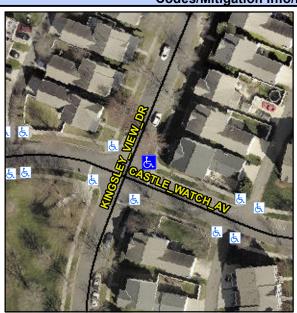
Field Measurements/Component Compliance							
	Compliance Description		Data	Compliance Description		Data	
	N/A	Ramp Length (in)	118.0	No	Ramp	Slope (%)	8.7
	No	Ramp Width (in)	41.0	Yes	Ramp	XSlope (%)	2.0
	N/A	Flare Type LT	N/A	N/A	Flare	Type RT	N/A
	N/A	Flare Slope LT (%)	N/A	N/A	Flare	Slope RT (%)	N/A
	N/A	Flare Traversable LT?	N/A	N/A	Flare	Traversable RT?	N/A
	N/A	Landing Length (in)	N/A	N/A	DWS	Provided?	N/A
	N/A	Landing Width (in)	N/A	N/A	DWS	Contrast?	N/A
	N/A	Landing Slope (%)	N/A	N/A	DWS	Length (in)	N/A
	N/A	Landing X Slope (%)	N/A	N/A	DWS	Full Width?	N/A
	N/A	Landing Curb? (Y/N)	N/A	N/A	DWS	Offset (in)	N/A
	N/A	Shared Landing?	N/A				
	N/A	Gutter Ponding?	N/A	N/A	Gutte	r Slope (%)	N/A
	N/A	Gutter Lip Ht (in)	N/A	N/A	Gutte	r X Slope (%)	N/A
	N/A	Painted X Walk1?	No	N/A	Painte	ed X Walk2?	No
		X Walk 1 Direction	To NW		X Wa	lk 2 Direction	To SW
	N/A	X Walk 1 Width (in)	N/A	N/A	X Wa	lk 2 Width (in)	N/A

X Walk 1 Slope (%)	0.1		X Wa	lk 2 Slope (%)	0.2
		X Walk 1 X Slope (%)	0.1		X Wa	lk 2 X Slope (%)	0.7
	N/A	Ramp inside XWalk1?	N/A	N/A	Ramp	inside XWalk2?	N/A
		Road Slope (%)	0.1	N/A	Clear	Space?	N/A
		Road X Slope (%)	1.0	N/A	Clear	Space to XWalk (in)	N/A
	N/A	Any Obstructions?	N/A	N/A	Storm	Grate/Utility Hazard?	N/A
		Obstruction Type			Storm	Grate/Utility Type	
			N/A				N/A
				Yes	Surfa	ce Condition? (G/P)	Good

Possible Solutions: Remove & Replace Curb Ramp With Two New Directional Ramps or Equivalent. Surveyor Notes: N/A PROW/ADA: Not Found, R304.5.1, R304.2.2

Total Cost: 3200.00
