# Access Compliance Report

## Public Rights-of-Way

### (Curb Ramps)

Intersection ID: 9451	Main Street: BREWTON_DR	Cross Street: EUREKA_ST	Location:	N
ADA ID: F29A4EB5FFF4	Ramp Type: Perp	Initial Pass/Fail: Fail	Overall Compliance: No	Severity Score: 12.5

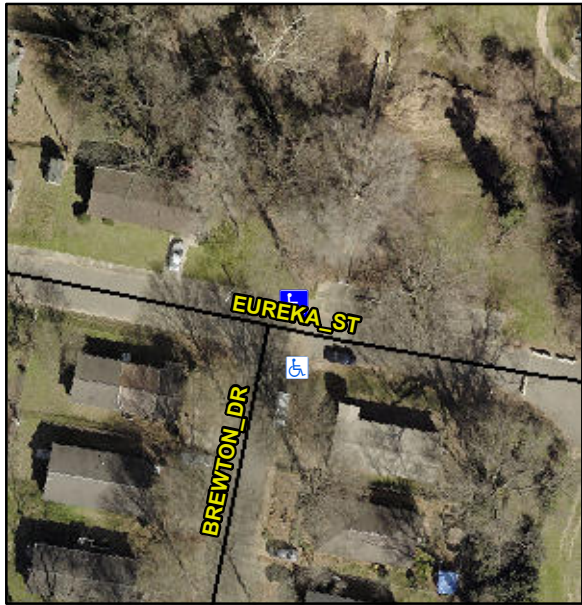
Possible Solutions:		<b>Remove &amp; Replace Entire Ramp.</b>					
	Surveyor Notes:		<b>N/A</b>					
	PROW/ADA:		<b>Not Found, R304.2.2</b>					
	Total Cost:		\$ 1850.00					
	Street 1 Name		<b>EUREKA ST</b>					
	Stop Condition-Street 2		<b>None</b>					
	Street 2 Name		<b>N/A</b>					
	Stop Condition-Street 1		<b>N/A</b>					
			<b>Compliance</b>	<b>Description</b>	<b>Data</b>	<b>Compliance</b>	<b>Description</b>	<b>Data</b>
			<b>N/A</b>	Ramp Length (in)	<b>49.5</b>	<b>No</b>	Ramp Slope (%)	<b>10.5</b>
			<b>Yes</b>	Ramp Width (in)	<b>50.0</b>	<b>Yes</b>	Ramp XSlope (%)	<b>0.5</b>
			<b>N/A</b>	Flare Type LT	<b>N/A</b>	<b>N/A</b>	Flare Type RT	<b>N/A</b>
			<b>N/A</b>	Flare Slope LT (%)	<b>N/A</b>	<b>N/A</b>	Flare Slope RT (%)	<b>N/A</b>
			<b>N/A</b>	Flare Traversable LT?	<b>N/A</b>	<b>N/A</b>	Flare Traversable RT?	<b>N/A</b>

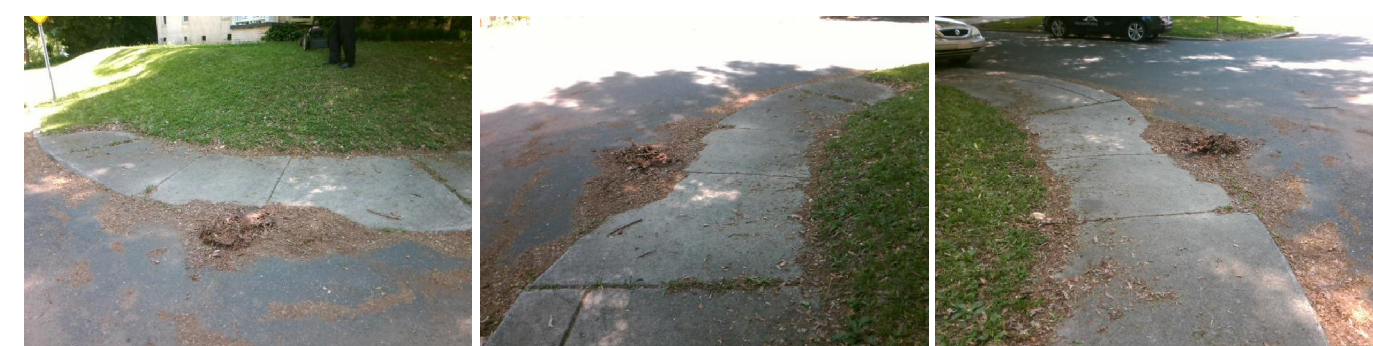
X Walk 1 X Slope (%)	<b>0.3</b>		X Walk 2 X Slope (%)	<b>N/A</b>
			<b>N/A</b>	Ramp inside XWalk1?	<b>N/A</b>	<b>N/A</b>	Ramp inside XWalk2?	<b>N/A</b>
				Road Slope (%)	<b>N/A</b>	<b>N/A</b>	Clear Space?	<b>N/A</b>
				Road X Slope (%)	<b>N/A</b>	<b>N/A</b>	Clear Space to XWalk (in)	<b>N/A</b>
			<b>N/A</b>	Any Obstructions?	<b>N/A</b>	<b>N/A</b>	Storm Grate/Utility Hazard?	<b>N/A</b>
				Obstruction Type			Storm Grate/Utility Type	
					<b>N/A</b>			<b>N/A</b>
						<b>Yes</b>	Surface Condition? (G/P)	<b>Good</b>
