# Access Compliance Report

## Public Rights-of-Way

### (Curb Ramps)

Intersection ID: 30200	Main Street: BIESTERFIELD_DR	Cross Street: SLATER_SPRINGS_DR	Location: NW
ADA ID: F29ADB370971	Ramp Type: Perp	Initial Pass/Fail: Fail	Overall Compliance: No
		Severity Score: 10

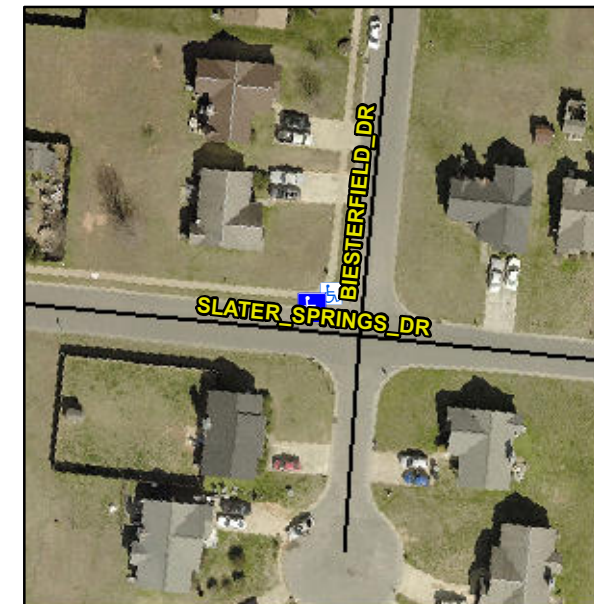
**Not Found, R304.5.1, R304.5.3**

Compliance	Description	Data	Compliance	Description	Data
N/A	Ramp Length (in)	50.0	Yes	Ramp Slope (%)	6.3
No	Ramp Width (in)	42.5	No	Ramp XSlope (%)	4.0
N/A	Flare Type LT	N/A	N/A	Flare Type RT	N/A
N/A	Flare Slope LT (%)	N/A	N/A	Flare Slope RT (%)	N/A
N/A	Flare Traversable LT?	N/A	N/A	Flare Traversable RT?	N/A
N/A	Landing Length (in)	N/A	N/A	DWS Provided?	N/A
N/A	Landing Width (in)	N/A	N/A	DWS Contrast?	N/A
N/A	Landing Slope (%)	N/A	N/A	DWS Length (in)	N/A
N/A	Landing X Slope (%)	N/A	N/A	DWS Full Width?	N/A
N/A	Landing Curb? (Y/N)	N/A	N/A	DWS Offset (in)	N/A
N/A	Shared Landing?	N/A			
N/A	Gutter Ponding?	N/A	N/A	Gutter Slope (%)	N/A
N/A	Gutter Lip Ht (in)	N/A	N/A	Gutter X Slope (%)	N/A
N/A	Painted X Walk1?	No	N/A	Painted X Walk2?	N/A
	X Walk 1 Direction	To S		X Walk 2 Direction	N/A
N/A	X Walk 1 Width (in)	N/A	N/A	X Walk 2 Width (in)	N/A
	X Walk 1 Slope (%)	1.4		X Walk 2 Slope (%)	N/A
	X Walk 1 X Slope (%)	2.1		X Walk 2 X Slope (%)	N/A

N/A	Ramp inside XWalk1?	N/A	N/A	Ramp inside XWalk2?	N/A
	Road Slope (%)	2.1	N/A	Clear Space?	N/A
	Road X Slope (%)	1.4	N/A	Clear Space to XWalk (in)	N/A
N/A	Any Obstructions?	N/A	N/A	Storm Grate/Utility Hazard?	N/A
	Obstruction Type			Storm Grate/Utility Type	
		N/A			N/A
			Yes	Surface Condition? (G/P)	Good

**Remove & Replace Entire Ramp.**
