Access Compliance Report

Public Rights-of-Way

(Curb Ramps)

Intersection ID: N/A	Main Street: HOOVER_CREEK_BV	Cross Street: STEELECROFT_PY	Location: SW
ADA ID: F29B8E2A8656	Ramp Type: Perp	Initial Pass/Fail: Fail	Overall Compliance: No
Severity Score: 12.5			
Codes/Mitigation Info/Possible Solution		Field Measurements/Component Compliance

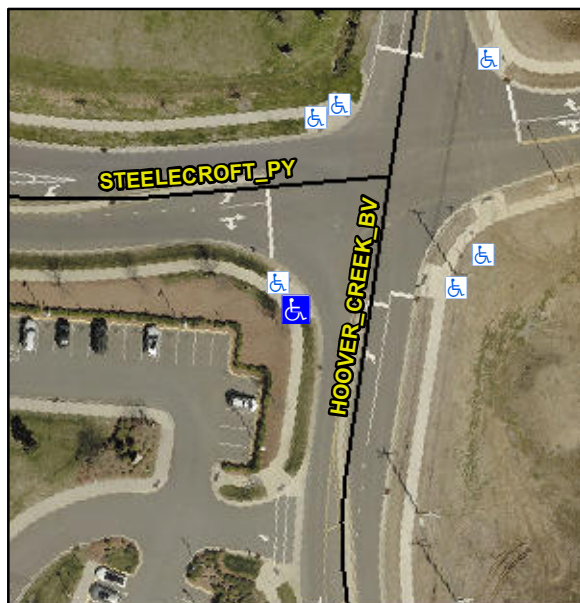
Compliance	Description	Data	Compliance	Description	Data
N/A	Ramp Length (in)	98.0	No	Ramp Slope (%)	8.8
Yes	Ramp Width (in)	48.0	Yes	Ramp XSlope (%)	1.7
N/A	Flare Type LT	N/A	N/A	Flare Type RT	N/A
N/A	Flare Slope LT (%)	N/A	N/A	Flare Slope RT (%)	N/A
N/A	Flare Traversable LT?	N/A	N/A	Flare Traversable RT?	N/A
N/A	Landing Length (in)	N/A	N/A	DWS Provided?	N/A
N/A	Landing Width (in)	N/A	N/A	DWS Contrast?	N/A
N/A	Landing Slope (%)	N/A	N/A	DWS Length (in)	N/A
N/A	Landing X Slope (%)	N/A	N/A	DWS Full Width?	N/A
N/A	Landing Curb? (Y/N)	N/A	N/A	DWS Offset (in)	N/A
N/A	Shared Landing?	N/A			
N/A	Gutter Ponding?	N/A	N/A	Gutter Slope (%)	N/A
N/A	Gutter Lip Ht (in)	N/A	N/A	Gutter X Slope (%)	N/A
N/A	Painted X Walk1?	No	N/A	Painted X Walk2?	N/A
	X Walk 1 Direction	To E		X Walk 2 Direction	N/A
N/A	X Walk 1 Width (in)	N/A	N/A	X Walk 2 Width (in)	N/A
	X Walk 1 Slope (%)	3.5		X Walk 2 Slope (%)	N/A
	X Walk 1 X Slope (%)	0.5		X Walk 2 X Slope (%)	N/A

N/A	Ramp inside XWalk1?	N/A	N/A	Ramp inside XWalk2?	N/A
	Road Slope (%)	N/A	N/A	Clear Space?	N/A
	Road X Slope (%)	N/A	N/A	Clear Space to XWalk (in)	N/A
N/A	Any Obstructions?	N/A	N/A	Storm Grate/Utility Hazard?	N/A
	Obstruction Type			Storm Grate/Utility Type	
		N/A			N/A
		Yes		Surface Condition? (G/P)	Good

Possible Solutions:

Remove & Replace Entire Ramp.
