Access Compliance Report

Public Rights-of-Way

(Curb Ramps)

Intersection ID: 14201	Main Street: RANLO_AV	Cross Street: BALDWIN_AV	Location: NW
ADA ID: F29FE169259C	Ramp Type: Perp	Initial Pass/Fail: Fail	Overall Compliance: No
		Severity Score: 25

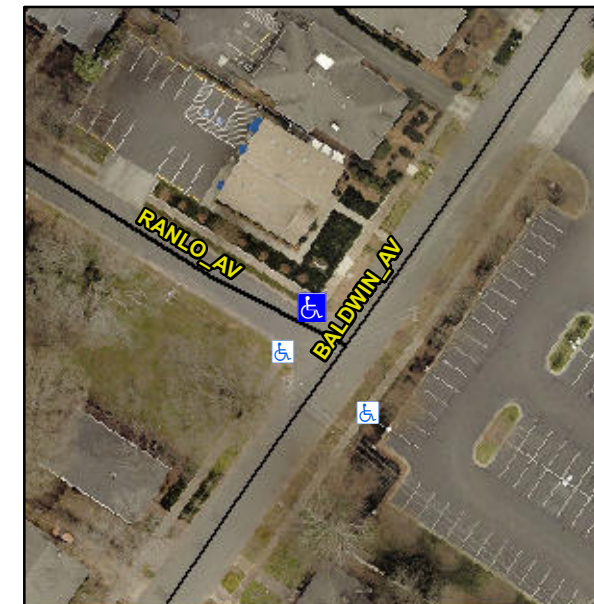
R304.2.2

Compliance	Description	Data	Compliance	Description	Data
N/A	Ramp Length (in)	48.0	No	Ramp Slope (%)	12.1
Yes	Ramp Width (in)	48.0	Yes	Ramp XSlope (%)	1.9
N/A	Flare Type LT	N/A	N/A	Flare Type RT	N/A
N/A	Flare Slope LT (%)	N/A	N/A	Flare Slope RT (%)	N/A
N/A	Flare Traversable LT?	N/A	N/A	Flare Traversable RT?	N/A
N/A	Landing Length (in)	N/A	N/A	DWS Provided?	N/A
N/A	Landing Width (in)	N/A	N/A	DWS Contrast?	N/A
N/A	Landing Slope (%)	N/A	N/A	DWS Length (in)	N/A
N/A	Landing X Slope (%)	N/A	N/A	DWS Full Width?	N/A
N/A	Landing Curb? (Y/N)	N/A	N/A	DWS Offset (in)	N/A
N/A	Shared Landing?	N/A			
N/A	Gutter Ponding?	N/A	N/A	Gutter Slope (%)	N/A
N/A	Gutter Lip Ht (in)	N/A	N/A	Gutter X Slope (%)	N/A
N/A	Painted X Walk1?	No	N/A	Painted X Walk2?	N/A
	X Walk 1 Direction	To SW		X Walk 2 Direction	N/A
N/A	X Walk 1 Width (in)	N/A	N/A	X Walk 2 Width (in)	N/A
	X Walk 1 Slope (%)	1.6		X Walk 2 Slope (%)	N/A
	X Walk 1 X Slope (%)	1.0		X Walk 2 X Slope (%)	N/A

Remove & Replace Entire Ramp.

\$ 1850.00
