Access Compliance Report

Public Rights-of-Way

(Curb Ramps)

| Intersection ID: 16008 | Main Street: SEDGEFIELD RD | Cross Street: WRISTON_PL | Location: SE |

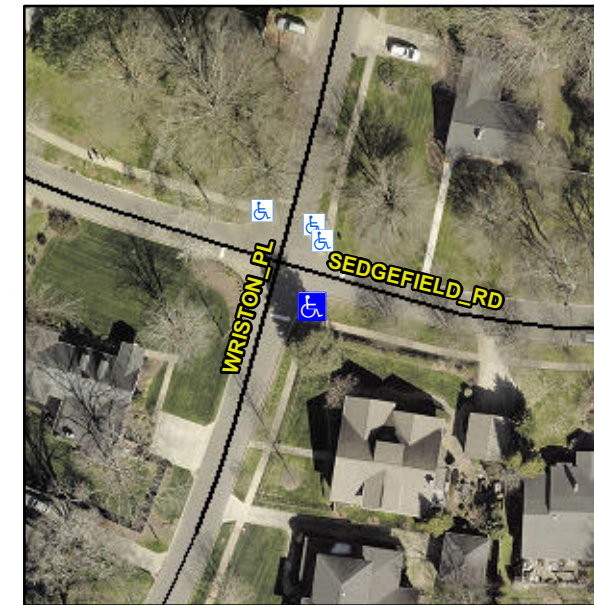
| ADA ID: F2A54B7155E7 | Ramp Type: Directional1 | Initial Pass/Fail: Fail | Overall Compliance: No |
| | | Severity Score: 10 | |

CURB LIP 1.0"

R304.5.1, R304.5.3

| Compliance | Description | Data | Compliance | Description | Data |
|---|---|---|---|---|---|
| No | Ramp Width (in) | 44.0 | N/A | Grade Break Slope (%) | 0.0 |
| No | Ramp XSlope (%) | 2.5 | | | |

Remove & Replace Entire Ramp.
