Access Compliance Report

Public Rights-of-Way

(Curb Ramps)

Intersection ID: 10003849	Main Street: DIXIE_RIVER_RD	Cross Street: NEW_FASHION_WY	Location: SW
ADA ID: F2AA3DEE964E	Ramp Type: Perp	Initial Pass/Fail: Fail	Overall Compliance: No
		Severity Score: 8.75

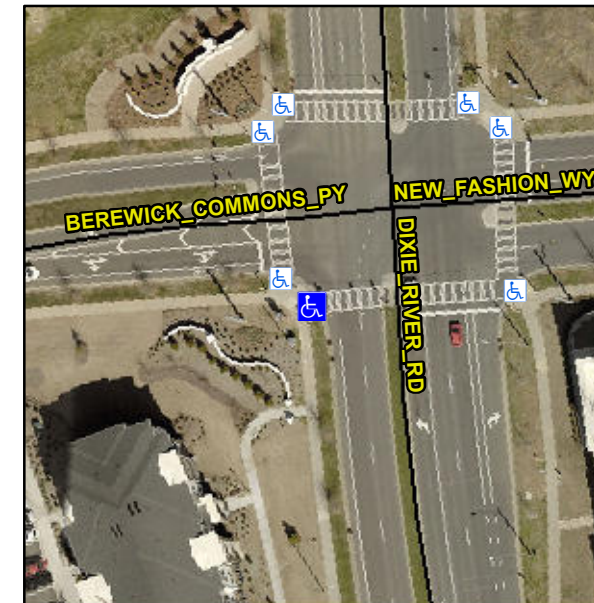
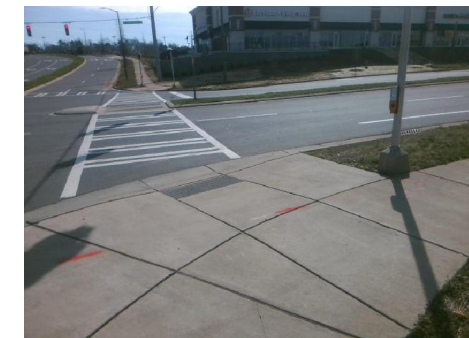
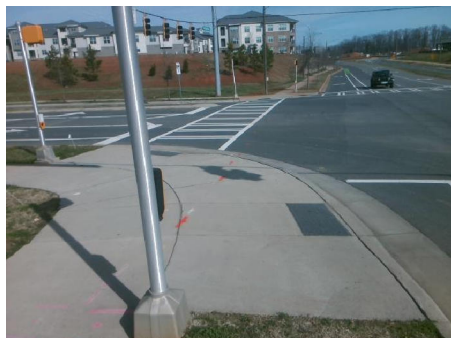
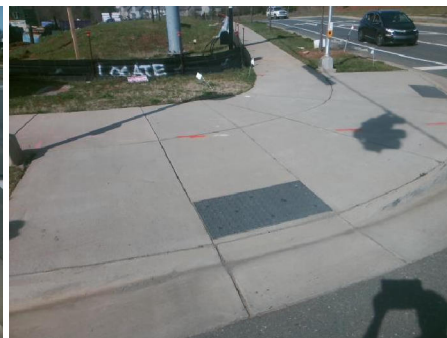
Not Found, R304.5.1

Compliance	Description	Data	Compliance	Description	Data
N/A	Ramp Length (in)	89.0	Yes	Ramp Slope (%)	6.3
No	Ramp Width (in)	47.0	Yes	Ramp XSlope (%)	0.6
N/A	Flare Type LT	N/A	N/A	Flare Type RT	N/A
N/A	Flare Slope LT (%)	N/A	N/A	Flare Slope RT (%)	N/A
N/A	Flare Traversable LT?	N/A	N/A	Flare Traversable RT?	N/A
N/A	Landing Length (in)	N/A	N/A	DWS Provided?	N/A
N/A	Landing Width (in)	N/A	N/A	DWS Contrast?	N/A
N/A	Landing Slope (%)	N/A	N/A	DWS Length (in)	N/A
N/A	Landing X Slope (%)	N/A	N/A	DWS Full Width?	N/A
N/A	Landing Curb? (Y/N)	N/A	N/A	DWS Offset (in)	N/A
N/A	Shared Landing?	N/A			
N/A	Gutter Ponding?	N/A	N/A	Gutter Slope (%)	N/A
N/A	Gutter Lip Ht (in)	N/A	N/A	Gutter X Slope (%)	N/A
N/A	Painted X Walk1?	Yes	N/A	Painted X Walk2?	N/A
	X Walk 1 Direction	To E		X Walk 2 Direction	N/A
N/A	X Walk 1 Width (in)	112.0	N/A	X Walk 2 Width (in)	N/A
	X Walk 1 Slope (%)	0.1		X Walk 2 Slope (%)	N/A
	X Walk 1 X Slope (%)	2.5		X Walk 2 X Slope (%)	N/A

N/A	Ramp inside XWalk1?	Yes	N/A	Ramp inside XWalk2?	N/A
	Road Slope (%)	N/A	N/A	Clear Space?	N/A
	Road X Slope (%)	N/A	N/A	Clear Space to XWalk (in)	N/A
N/A	Any Obstructions?	N/A	N/A	Storm Grate/Utility Hazard?	N/A
	Obstruction Type			Storm Grate/Utility Type	
		N/A			N/A
			Yes	Surface Condition? (G/P)	Good

Remove & Replace Entire Ramp.

Total Cost: \$ 1850.00
