# Access Compliance Report

## Public Rights-of-Way

### (Curb Ramps)

Intersection ID: N/A	Main Street: ELEANOR_RIGBY_RD	Cross Street: MOONLIGHT_BAY_WY	Location: NW
ADA ID: F2AF68714732	Ramp Type: BlendTrans1	Initial Pass/Fail: Fail	Overall Compliance: No
		Severity Score: 10

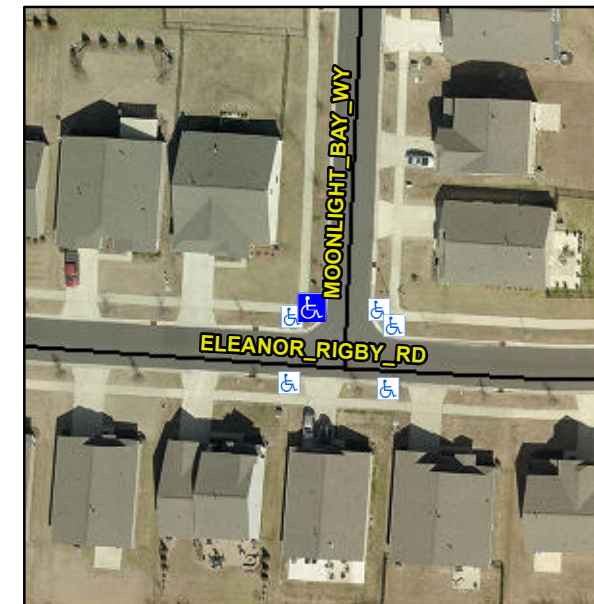
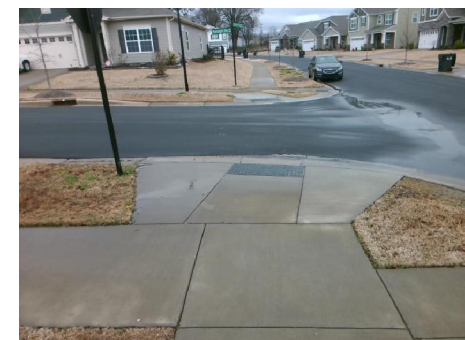
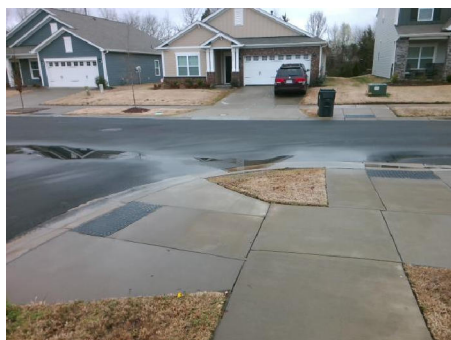
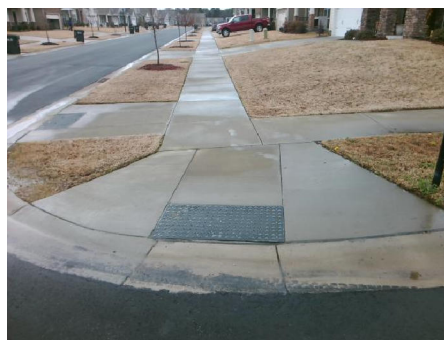
Compliance	Description	Data	Compliance	Description	Data
N/A	Ramp Length (in)	87.0	Yes	BlendTrans Slope (%)	4.2
No	Ramp Width (in)	41.0	No	BlendTrans XSlope (%)	3.1
N/A	Flare Type LT	N/A	N/A	Flare Type RT	N/A
N/A	Flare Slope LT (%)	N/A	N/A	Flare Slope RT (%)	N/A
N/A	Flare Traversable LT?	N/A	N/A	Flare Traversable RT?	N/A
N/A	Landing Length (in)	N/A	N/A	DWS Provided?	N/A
N/A	Landing Width (in)	N/A	N/A	DWS Contrast?	N/A
N/A	Landing Slope (%)	N/A	N/A	DWS Length (in)	N/A
N/A	Landing X Slope (%)	N/A	N/A	DWS Full Width?	N/A
N/A	Landing Curb? (Y/N)	N/A	N/A	DWS Offset (in)	N/A
N/A	Shared Landing?	N/A			
N/A	Gutter Ponding?	N/A	N/A	Gutter Slope (%)	N/A
N/A	Gutter Lip Ht (in)	N/A	N/A	Gutter X Slope (%)	N/A
N/A	Painted X Walk1?	No	N/A	Painted X Walk2?	N/A
	X Walk 1 Direction	To E		X Walk 2 Direction	N/A
	X Walk 1 Width (in)	N/A		X Walk 2 Width (in)	N/A
	X Walk 1 Slope (%)	1.6		X Walk 2 Slope (%)	N/A
	X Walk 1 X Slope (%)	1.6		X Walk 2 X Slope (%)	N/A

N/A	Ramp inside XWalk1?	N/A	N/A	Ramp inside XWalk2?	N/A
	Road Slope (%)	1.6		Clear Space?	N/A
	Road X Slope (%)	1.6	N/A	Clear Space to XWalk (in)	N/A
N/A	Any Obstructions?	N/A	N/A	Storm Grate/Utility Hazard?	N/A
	Obstruction Type			Storm Grate/Utility Type	
		N/A			N/A
			Yes	Surface Condition? (G/P)	Good
			N/A	Curb Slope (%)	3.1

**Remove & Replace Curb Ramp With Two New Directional Ramps or Equivalent.**

**R304.5.1, R304.5.3**
