Access Compliance Report

Public Rights-of-Way

(Curb Ramps)

| Intersection ID: 12048 | Main Street: S_GRAHAM_ST | Cross Street: W_3RD_ST | Location: W |

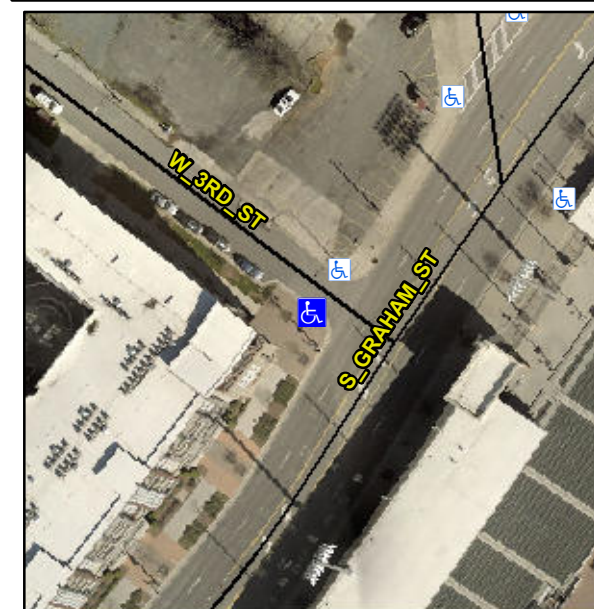
| ADA ID: F2B03D95E04E | Ramp Type: Perp | Initial Pass/Fail: Pass | Overall Compliance: No |
| Severity Score: 5 | | | |

**R304.2.2-Perp, R304.3.2-Para,
R304.2.3, R305.2**

| Compliance | Description | Data | Compliance | Description | Data |
|---|---|---|---|---|---|
| No | Flare Type | Curbed_WithWalkSurface | No | Flare Type RT | N/A |
| No | Flare Slope LT (%) | N/A | N/A | Flare Slope RT (%) | N/A |
| No | Landing Slope (%) | 2.8 | Yes | DWS Length (in) | 24.0 |
| N/A | Landing Curb? (Y/N) | No | No | DWS Offset (in) | 4.0 |

Possible Solutions:

Remove & Replace Entire Ramp.
