Access Compliance Report

Public Rights-of-Way

(Curb Ramps)

Intersection ID: 13541	Main Street: CENTRAL_AV	Cross Street: EASTCREST_DR	Location: NE
ADA ID: F2B6E920D008	Ramp Type: Perp	Initial Pass/Fail: Fail	Overall Compliance: No
Severity Score: 13.75			
Codes/Mitigation Info/Possible Solution		Field Measurements/Component Compliance

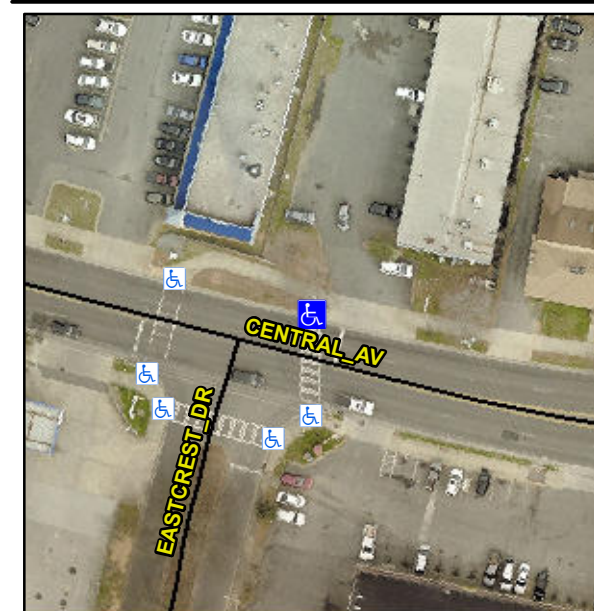
Not Found, R304.2.2

Compliance	Description	Data	Compliance	Description	Data
N/A	Ramp Length (in)	86.0	No	Ramp Slope (%)	8.7
Yes	Ramp Width (in)	51.0	Yes	Ramp XSlope (%)	3.4
N/A	Flare Type LT	N/A	N/A	Flare Type RT	N/A
N/A	Flare Slope LT (%)	N/A	N/A	Flare Slope RT (%)	N/A
N/A	Flare Traversable LT?	N/A	N/A	Flare Traversable RT?	N/A
N/A	Landing Length (in)	N/A	N/A	DWS Provided?	N/A
N/A	Landing Width (in)	N/A	N/A	DWS Contrast?	N/A
N/A	Landing Slope (%)	N/A	N/A	DWS Length (in)	N/A
N/A	Landing X Slope (%)	N/A	N/A	DWS Full Width?	N/A
N/A	Landing Curb? (Y/N)	N/A	N/A	DWS Offset (in)	N/A
N/A	Shared Landing?	N/A			
N/A	Gutter Ponding?	N/A	N/A	Gutter Slope (%)	N/A
N/A	Gutter Lip Ht (in)	N/A	N/A	Gutter X Slope (%)	N/A
N/A	Painted X Walk1?	Yes	N/A	Painted X Walk2?	N/A
	X Walk 1 Direction	To S		X Walk 2 Direction	N/A
N/A	X Walk 1 Width (in)	110.0	N/A	X Walk 2 Width (in)	N/A
	X Walk 1 Slope (%)	6.5		X Walk 2 Slope (%)	N/A
	X Walk 1 X Slope (%)	3.5		X Walk 2 X Slope (%)	N/A

N/A	Ramp inside XWalk1?	Yes	N/A	Ramp inside XWalk2?	N/A
	Road Slope (%)	N/A	N/A	Clear Space?	N/A
	Road X Slope (%)	N/A	N/A	Clear Space to XWalk (in)	N/A
N/A	Any Obstructions?	N/A	N/A	Storm Grate/Utility Hazard?	N/A
	Obstruction Type			Storm Grate/Utility Type	
		N/A			N/A
		Yes		Surface Condition? (G/P)	Good

Remove & Replace Entire Ramp.
