Access Compliance Report Public Rights-of-Way (Curb Ramps)

Intersection ID: 11696 Main Street: W_5TH_ST Cross Street: WILKES PL Location: **Overall Compliance: No** ADA ID: F2B865C0F1AF Ramp Type: PerpDiag Initial Pass/Fail: Fail Severity Score: 51.25

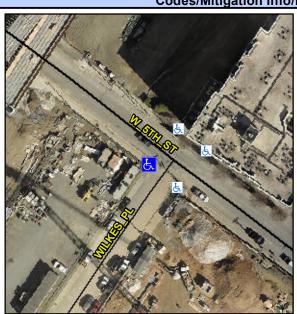
Field Measurements/Component Compnance					
Compliance Description			Compliance Description		Data
N/A	Ramp Length (in)	52.0	Yes	Ramp Slope (%)	7.6
No	Ramp Width (in)	24.0	Yes	Ramp XSlope (%)	2.3
N/A	Flare Type LT	N/A	N/A	Flare Type RT	N/A
N/A	Flare Slope LT (%)	N/A	N/A	Flare Slope RT (%)	N/A
N/A	Flare Traversable LT?	N/A	N/A	Flare Traversable RT?	N/A
N/A	Landing Length (in)	N/A	N/A	DWS Provided?	N/A
N/A	Landing Width (in)	N/A	N/A	DWS Contrast?	N/A
N/A	Landing Slope (%)	N/A	N/A	DWS Length (in)	N/A
N/A	Landing X Slope (%)	N/A	N/A	DWS Full Width?	N/A
N/A	Landing Curb? (Y/N)	N/A	N/A	DWS Offset (in)	N/A
N/A	Shared Landing?	N/A			
N/A	Gutter Ponding?	N/A	N/A	Gutter Slope (%)	N/A
N/A	Gutter Lip Ht (in)	N/A	N/A	Gutter X Slope (%)	N/A
N/A	Painted X Walk1?	No	N/A	Painted X Walk2?	No
	X Walk 1 Direction	To SE		X Walk 2 Direction	To NE
N/A	X Walk 1 Width (in)	N/A	N/A	X Walk 2 Width (in)	N/A
	X Walk 1 Slope (%)	2.8		X Walk 2 Slope (%)	0.7

X Walk 1 X Slope (%)	1.2		X Walk 2 X Slope (%)	0.4
N/A	Ramp inside XWalk1?	N/A	N/A	Ramp inside XWalk2?	N/A
	Road Slope (%)	2.4	N/A	Clear Space?	N/A
	Road X Slope (%)	4.5	N/A	Clear Space to XWalk (in)	N/A
N/A	Any Obstructions?	N/A	N/A	Storm Grate/Utility Hazard?	N/A
	Obstruction Type		l	Storm Grate/Utility Type	
		N/A			N/A
			No	Surface Condition? (G/P)	Poor

Possible Solutions: Remove & Replace Curb Ramp With Two New Directional Ramps or Equivalent. Surveyor Notes: N/A PROW/ADA: Not Found, R304.5.1, R302.7
