# Access Compliance Report

## Public Rights-of-Way

### (Curb Ramps)

| Intersection ID: 10028518 | Main Street: HOLABIRD_LN | Cross Street: N/A | Location: E |

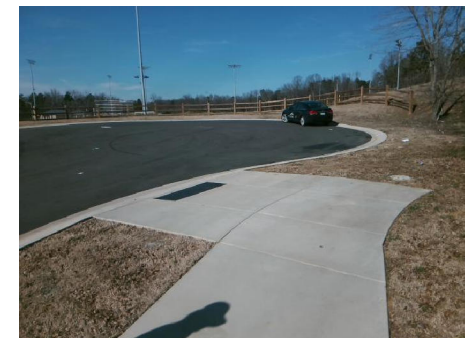
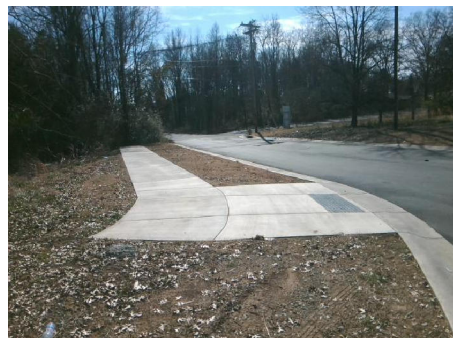
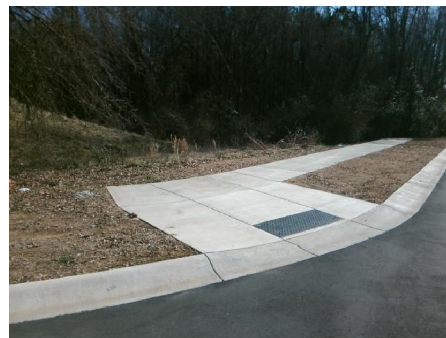
| Compliance | Description | Data | Compliance | Description | Data |
|---|---|---|---|---|---|
| N/A | Landing Curb? (Y/N) | No | No | DWS Offset (in) | 4.0 |
| Yes | Gutter Lip Ht (in) | 0.0 | No | Gutter X Slope (%) | 3.5 |

**Remove & Replace Detectable Warning System. Remove & Replace Gutter.**

**R305.2, R304.5.3**
