# Access Compliance Report

## Public Rights-of-Way

### (Curb Ramps)

| Intersection ID: 14923 | Main Street: EAST_BV | Cross Street: EWING_AV | Location: SW |

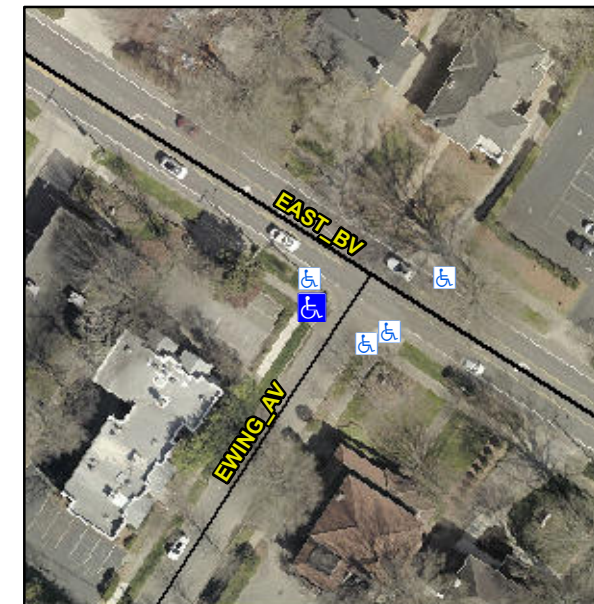
| ADA ID: F2BFDAFDE292 | Ramp Type: Perp | Initial Pass/Fail: Fail | Overall Compliance: No |
| | | Severity Score: 1.25 | |

**Not Found, R304.5.3**

| Compliance | Description | Data | Compliance | Description | Data |
|---|---|---|---|---|---|
| Yes | Ramp Width (in) | 71.0 | No | Ramp XSlope (%) | 2.2 |

**Remove & Replace Entire Ramp.**

Total Cost: \$ 1850.00
